**STRUCTURAL STABILITY AND SAFETY FACTOR  
ASSESSMENT per CCR Rule 257.73 (d) and (e)**

*NIPSCO, R.M. Schahfer Generating Station, Waste Disposal Area CCR Unit*

**Northern Indiana Public Service Company, LLC (NIPSCO)**

**WSP USA Inc.**

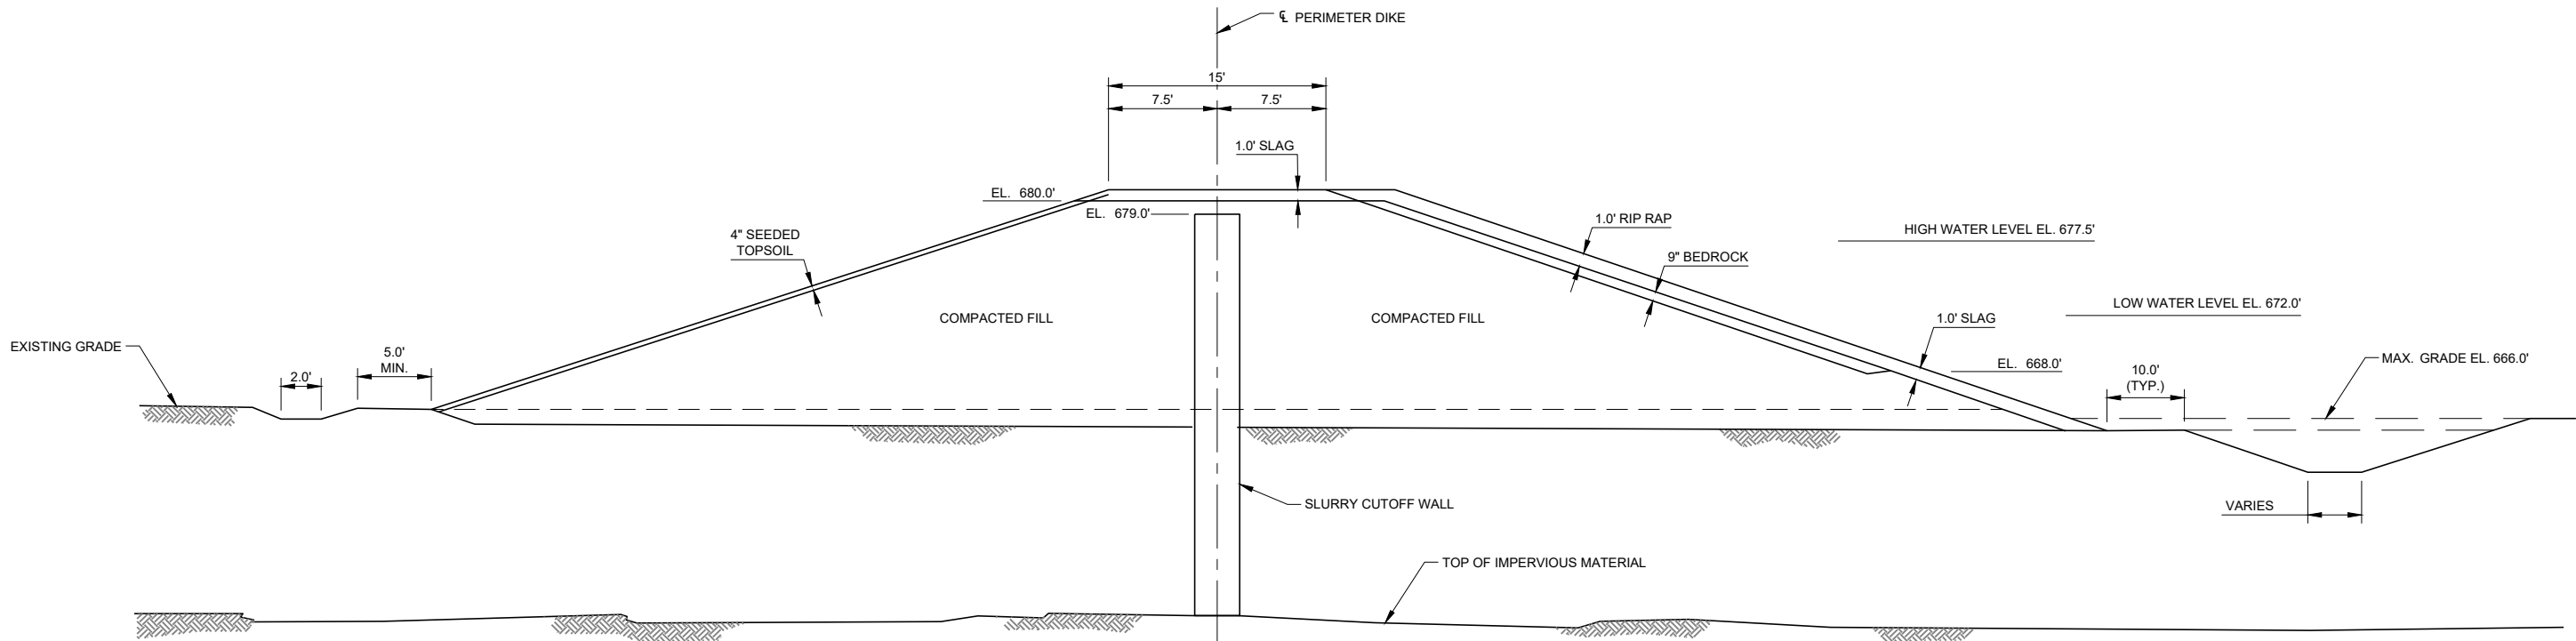
**REFERENCE**  
CROSS SECTION DETAIL FROM SARGENT & LUNDY CONSTRUCTION; DRAWING C-19;  
SETTLING BASINS DIKEWORK SECTIONS AND DETAILS; SHEET - 1; REV. F; 1982-07-13.

The geotechnical model for the WDA is dense silty sand (embankment soil) overlying dense silty sand (subgrade). Figure 4, attached, shows the typical designed cross section of the WDA. Figure 5, attached, shows the geotechnical model for the WDA to be used for the factor of safety analysis. It should be noted that for the purposes of the factor of safety analysis prepared for the WDA and described in Section 4 of this report, the designed crest elevation (681 feet above mean sea level (ft MSL)) was used as the highest elevation found on the WDA, which is a worst-case scenario. The surveyed lowest crest elevation (680 ft MSL, Marbach, 2011) was used in the spillway capacity calculations because that is a worst-case scenario.

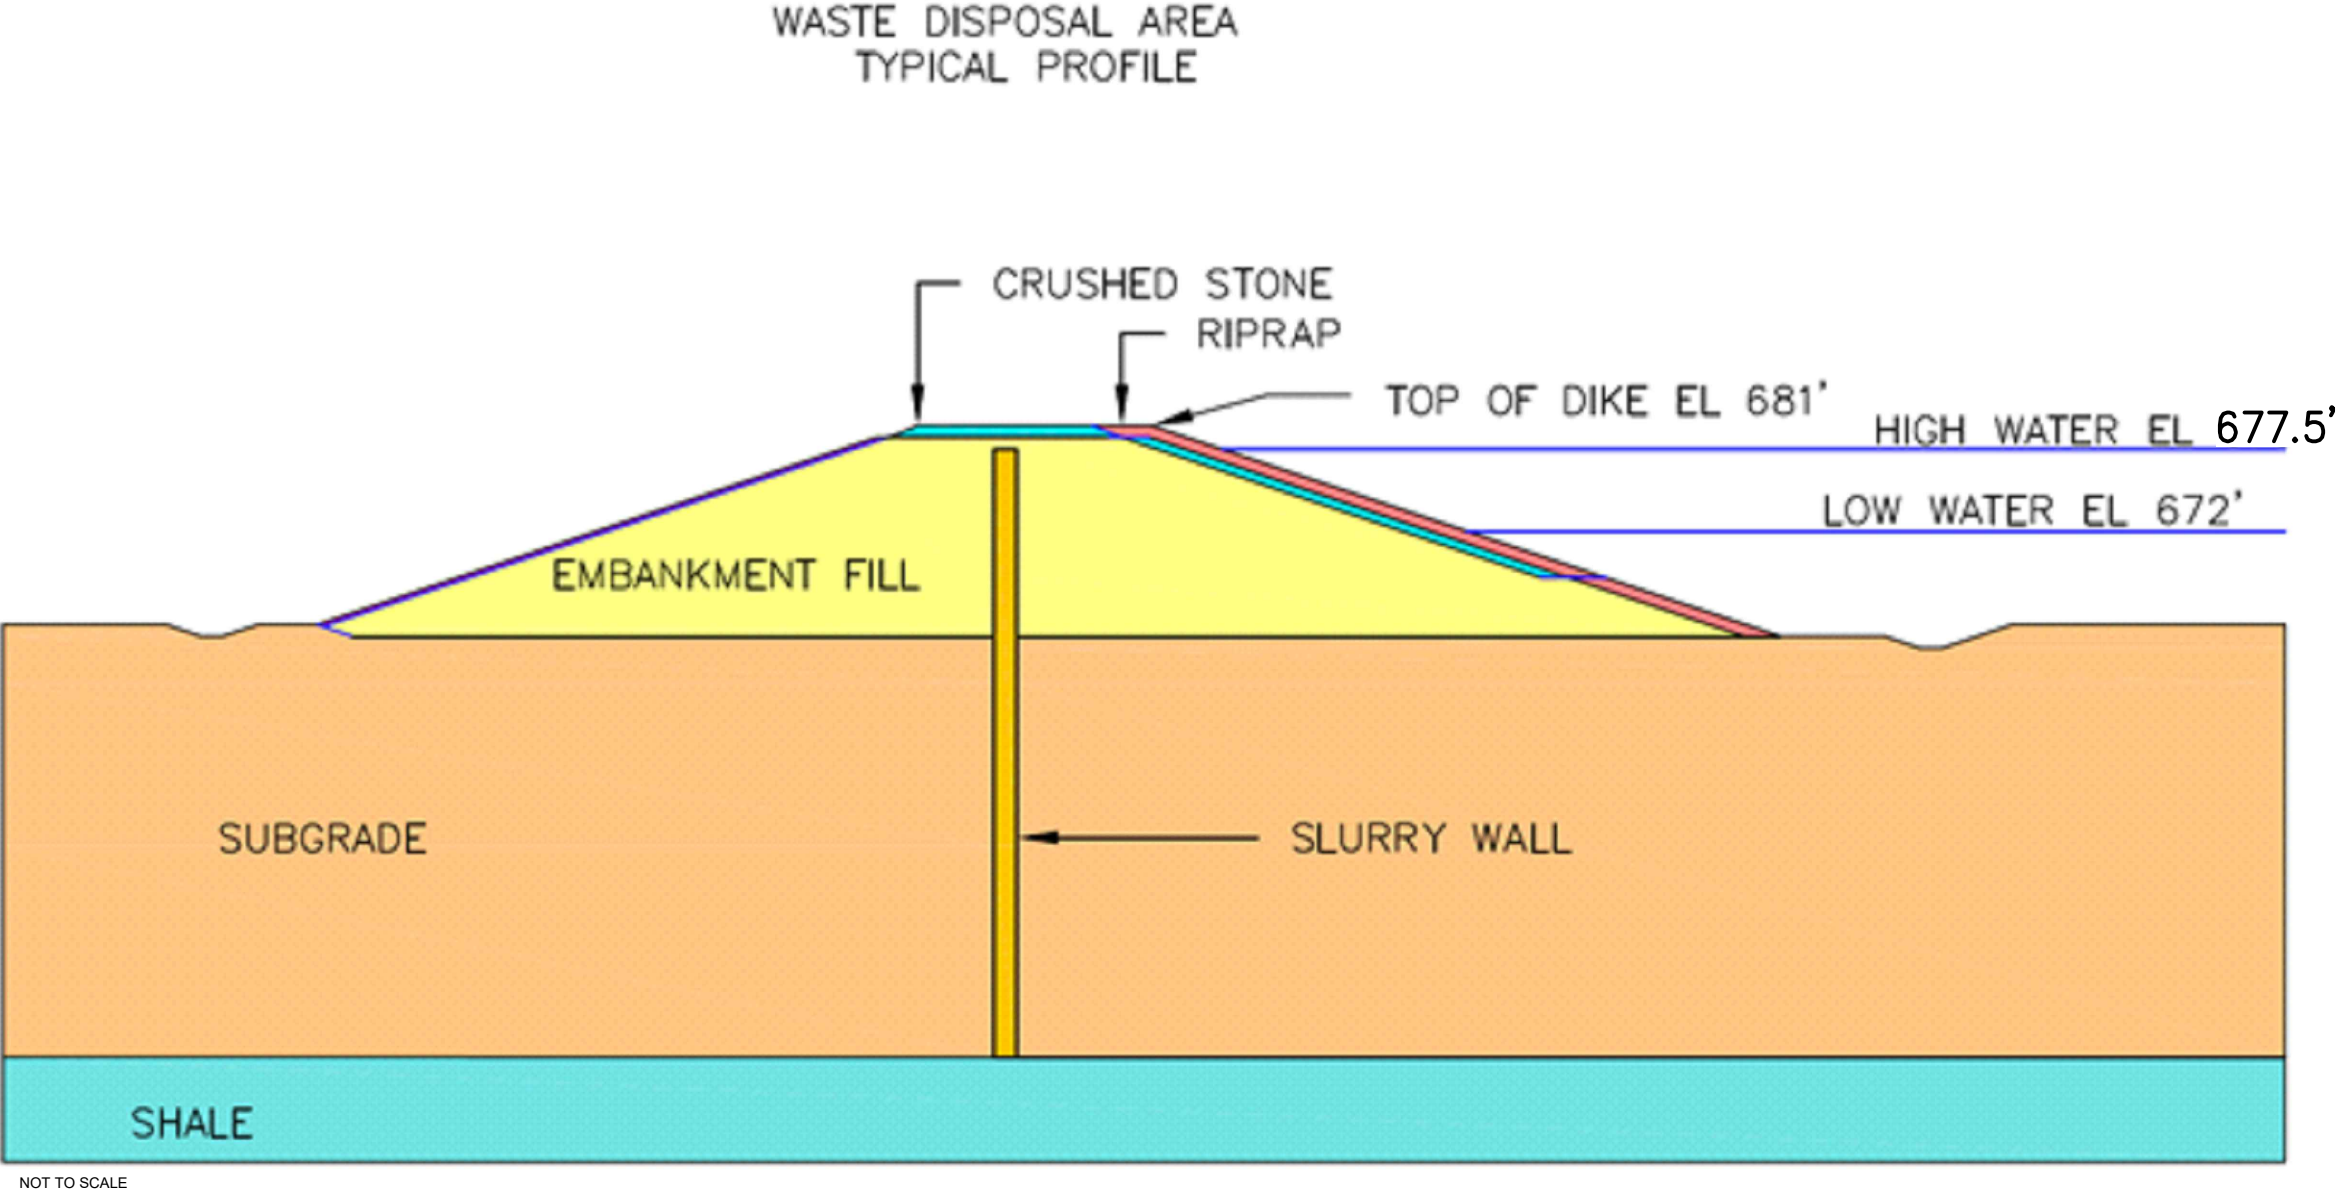
**REFERENCE**  
PROFILE DETAIL FROM SARGENT & LUNDY CONSTRUCTION; DRAWING C-19; SETTLING BASINS  
DIKEWORK SECTIONS AND DETAILS; SHEET - 1; REV. F; 1982-07-13.

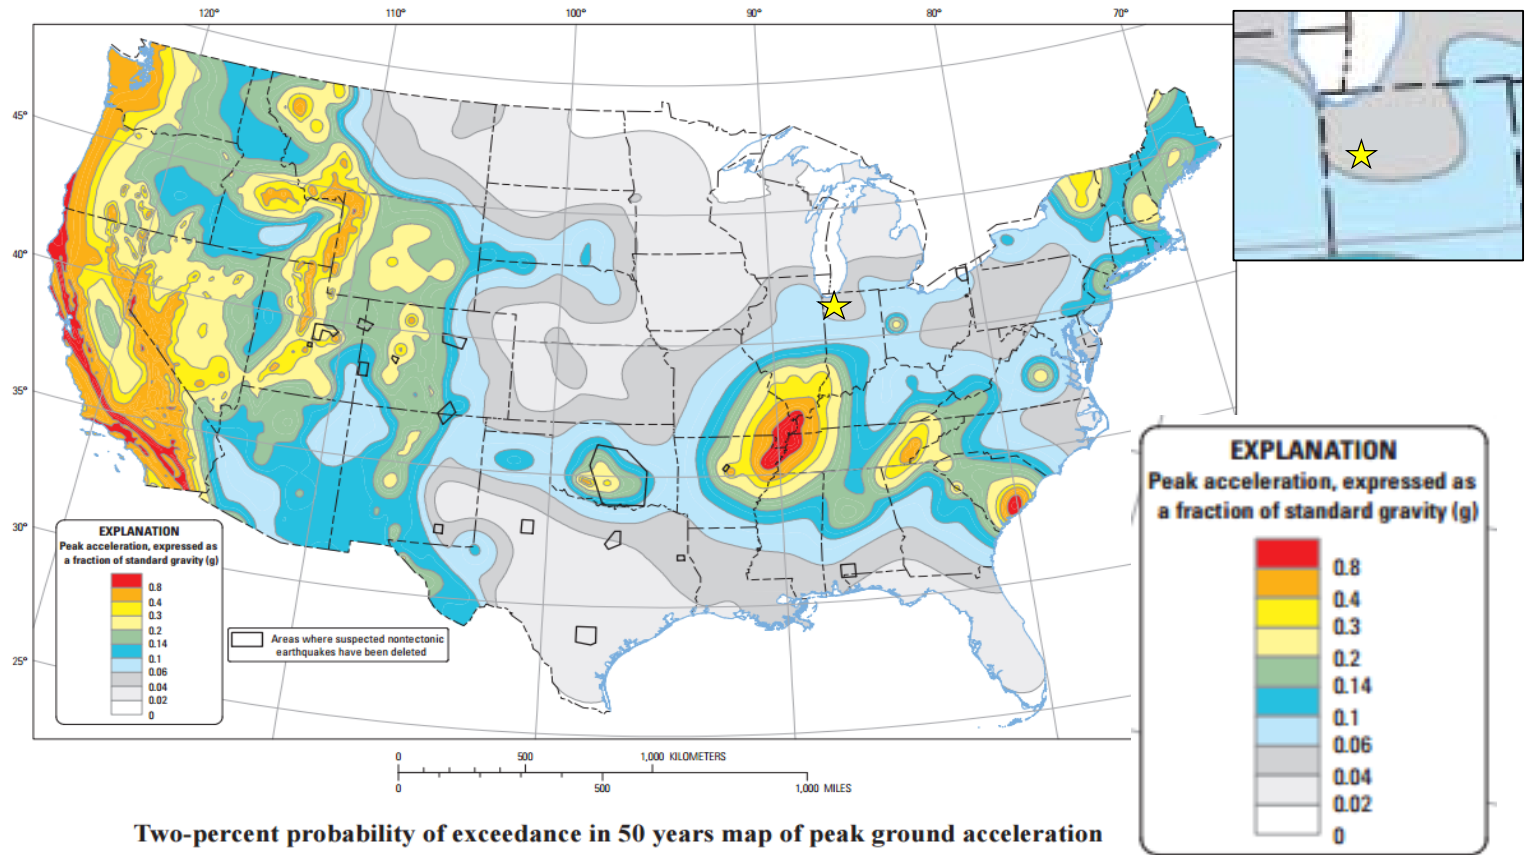
Two-percent probability of exceedance in 50 years map of peak ground acceleration

Golder has elected to use  
the  $PGA_M = 0.088g$ ,  
representing value within  
soil region of strata.  
Horizontal Ground  
Acceleration for  
Analysis =  $(1/2) \cdot 0.088g$   
= 0.044g (per Hynes-  
Griffin & Franklin (1984)).

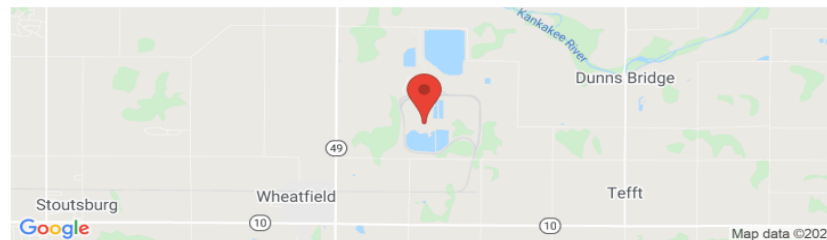
Date: 6/7/2021, 12:36:21 PM  
Design Code Reference Document: ASCE7-16  
Risk Category: IV  
Site Class: D - Stiff Soil

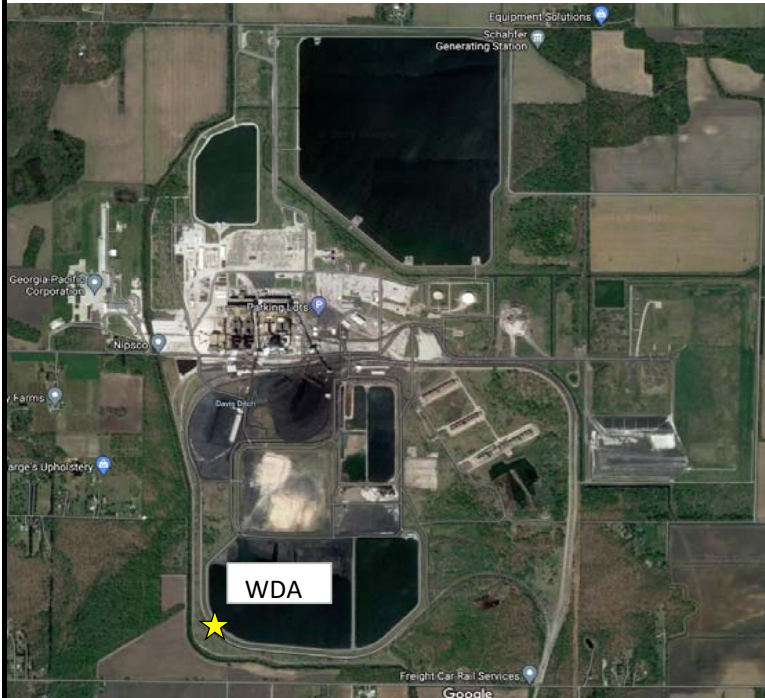
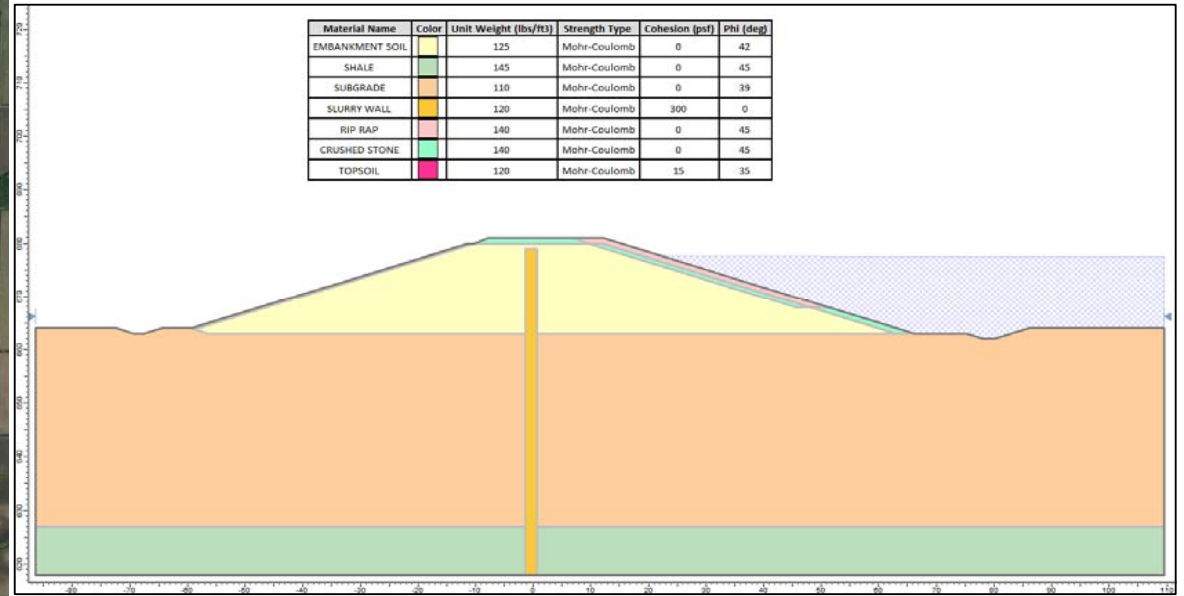
**1B**

Cross-Section A-A' Profile Typical Embankment Cross-Section  
for West and South Sides of the WDA  
(per Sargent & Lundy Construction Drawing C-19 (1982))

The critical section of the exterior dike was determined by using the existing topography (2011) and considering the interpreted soil profile from the subsurface investigations, and phreatic surface. The critical cross section is the cross section anticipated to be the most susceptible of all cross sections to structural failure based on appropriate engineering considerations, including loading conditions.

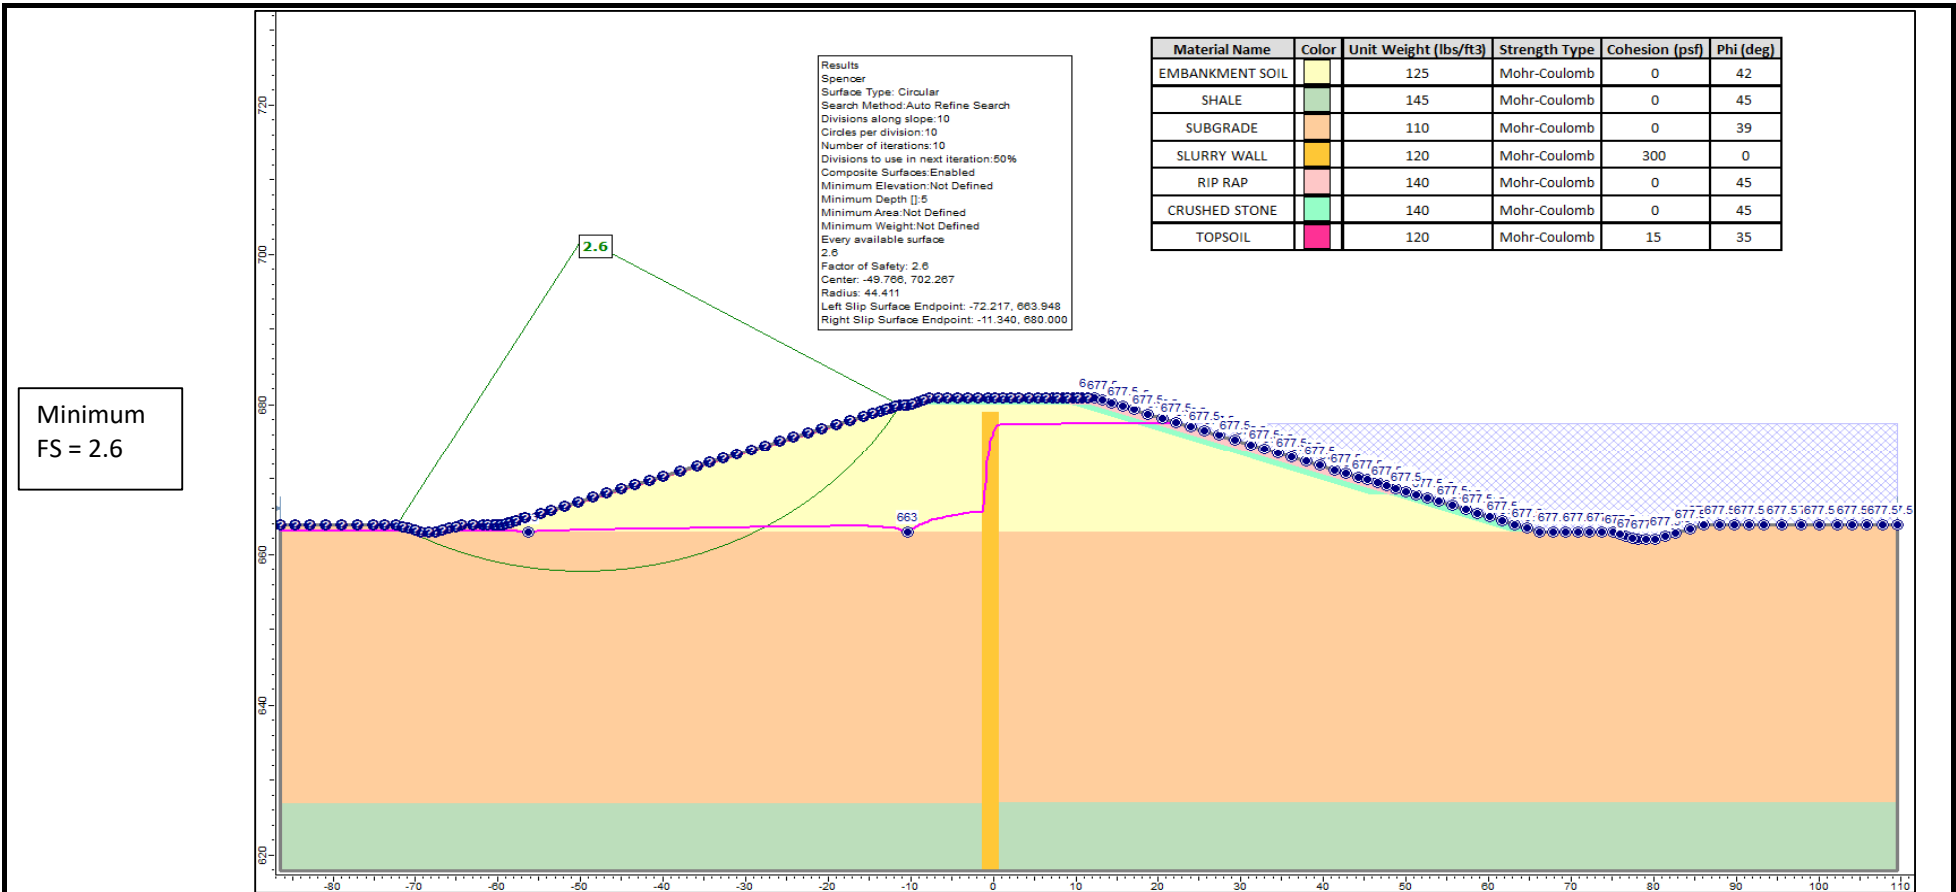
**2A**

| | | | DATE | Jun 2021 | TITLECross-Section A-A' Maximum Pool Depth Steady State Loading - Circular Failure Plane | | |

Minimum  
FS = 2.7

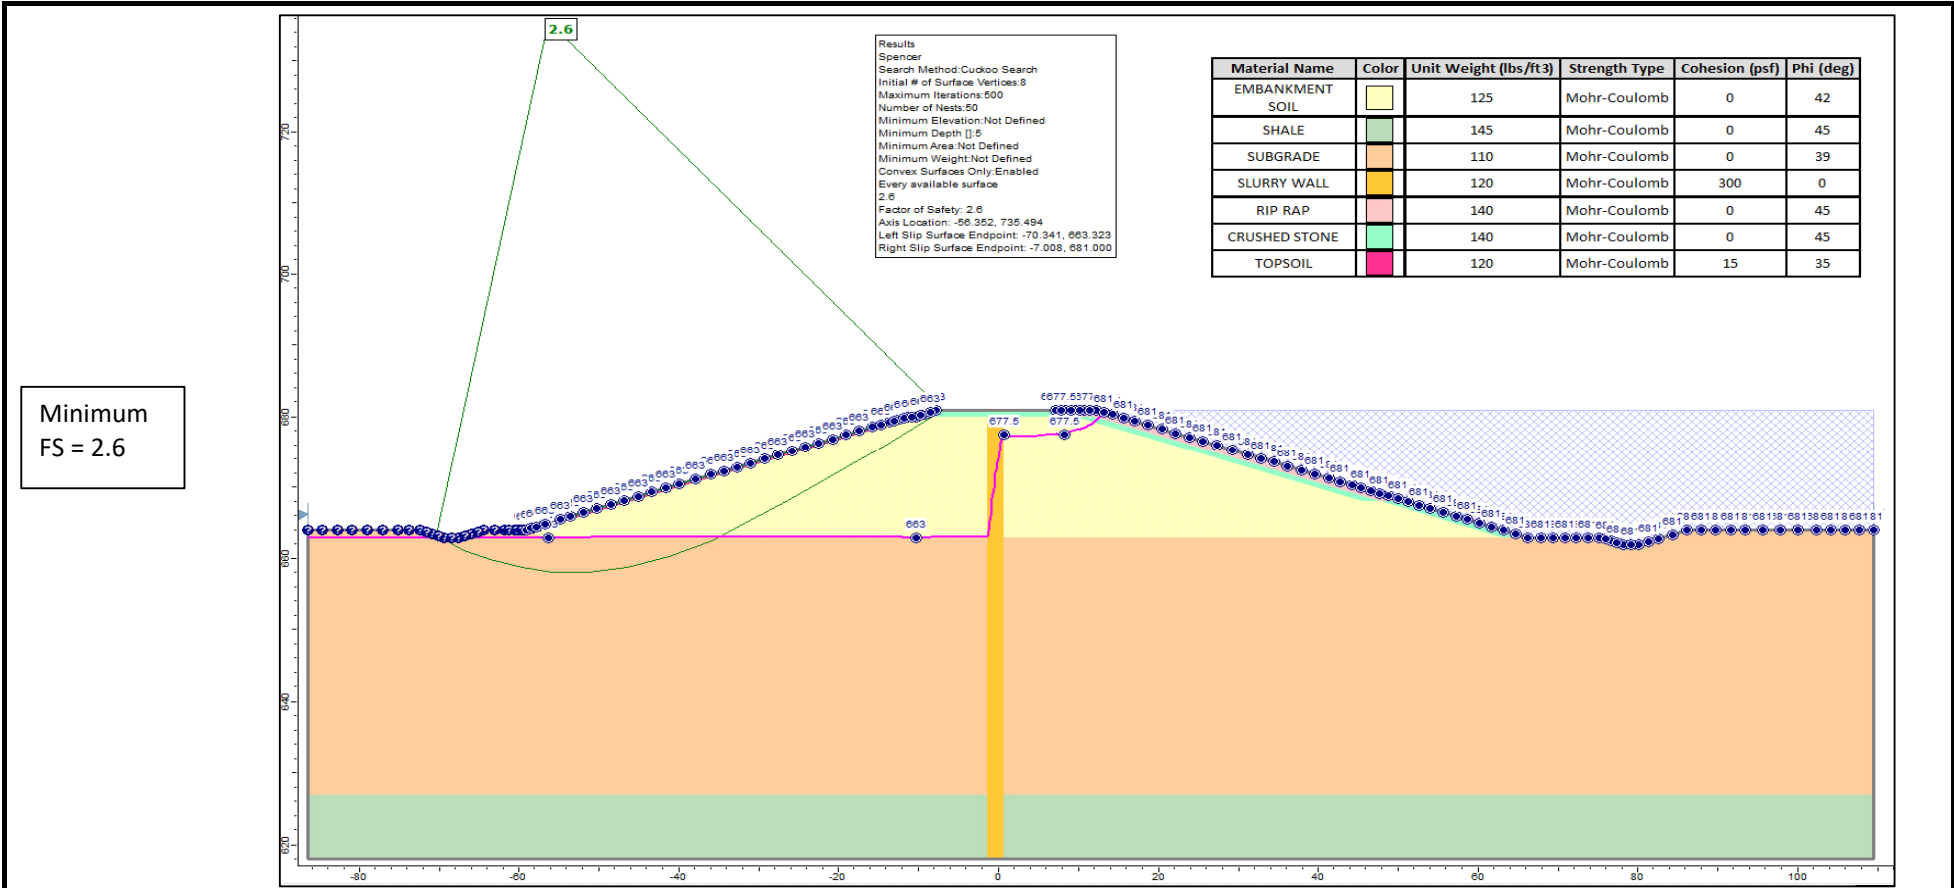
| | DATE | Jun 2021 | TITLE <b>Cross-Section A-A' Maximum Pool Surge - Non-Circular Failure Plane</b> | | |

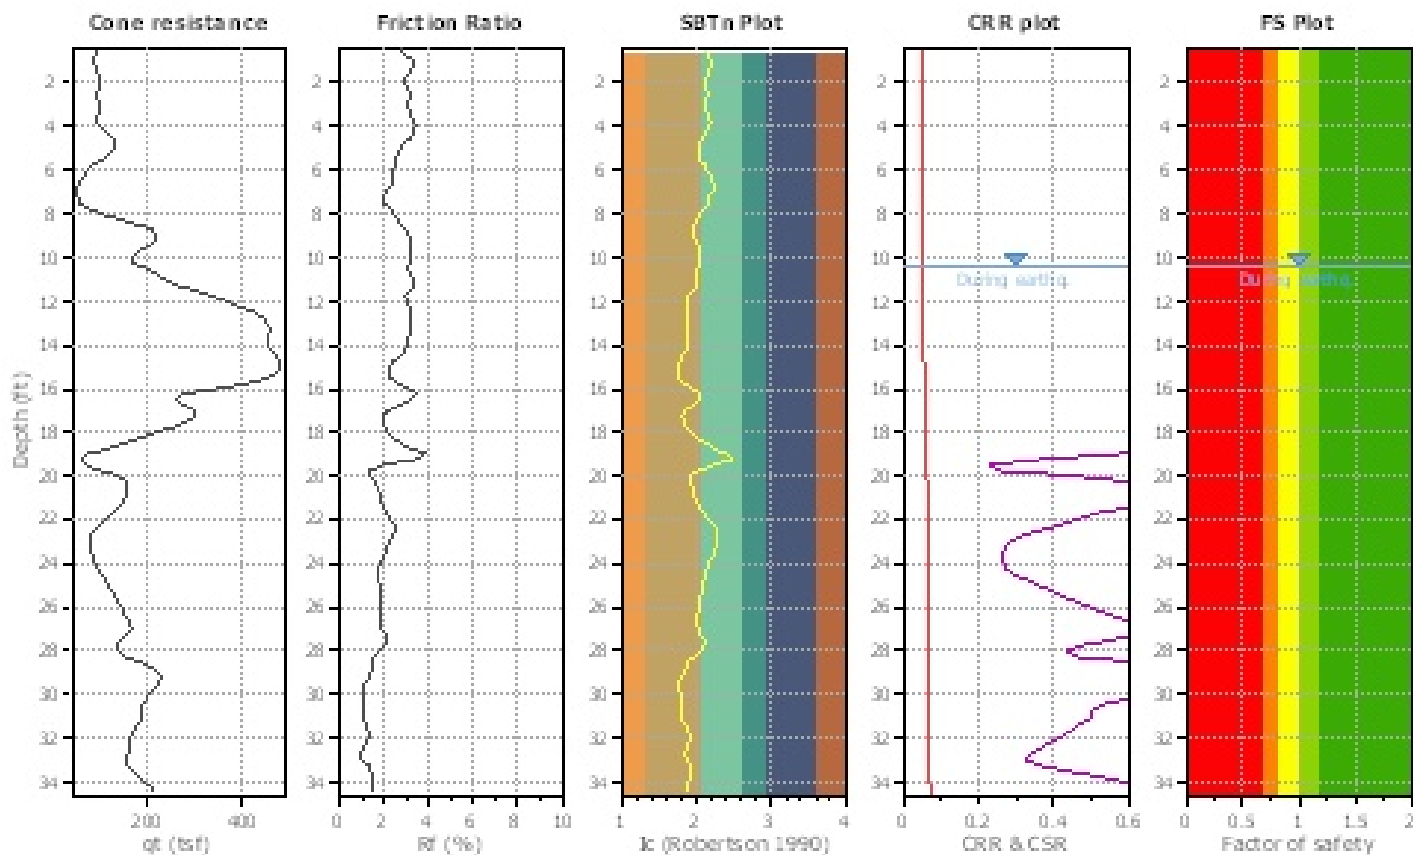
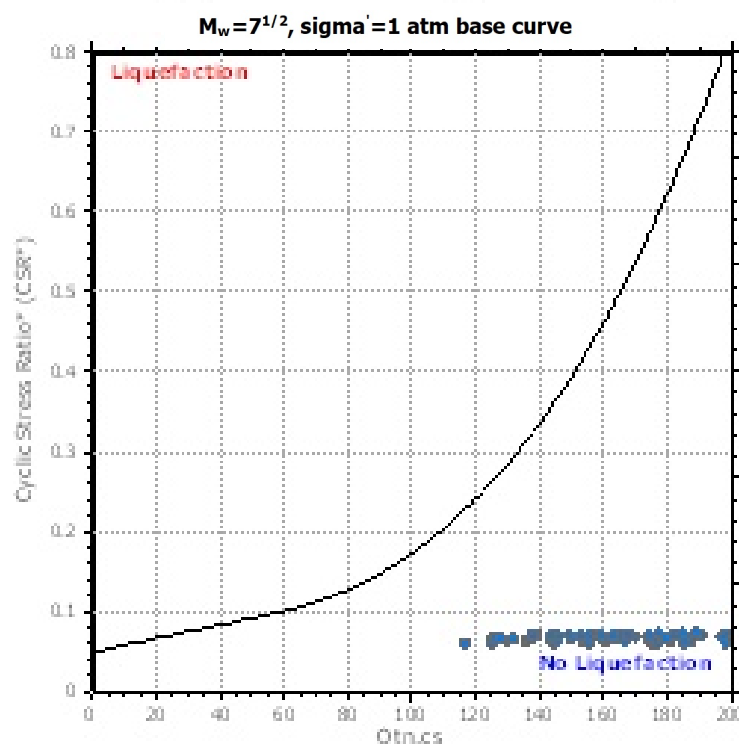
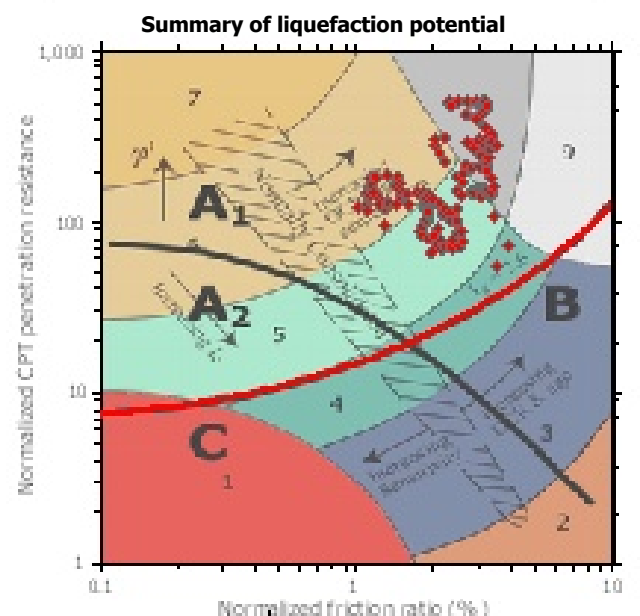
| Earthquake magnitude $M_w$ : | 7.00 | Ic cut-off value: | 2.60 | Trans. detect. applied: | No | Limit depth: | N/A |
| Peak ground acceleration: | 0.09 | Unit weight calculation: | Based on SBT | $K_0$ applied: | Yes | MSF method: | Method based |

Zone A<sub>1</sub>: Cyclic liquefaction likely depending on size and duration of cyclic loading  
 Zone A<sub>2</sub>: Cyclic liquefaction and strength loss likely depending on loading and ground geometry  
 Zone B: Liquefaction and post-earthquake strength loss unlikely, check cyclic softening  
 Zone C: Cyclic liquefaction and strength loss possible depending on soil plasticity, brittleness/sensitivity, strain to peak undrained strength and ground geometry

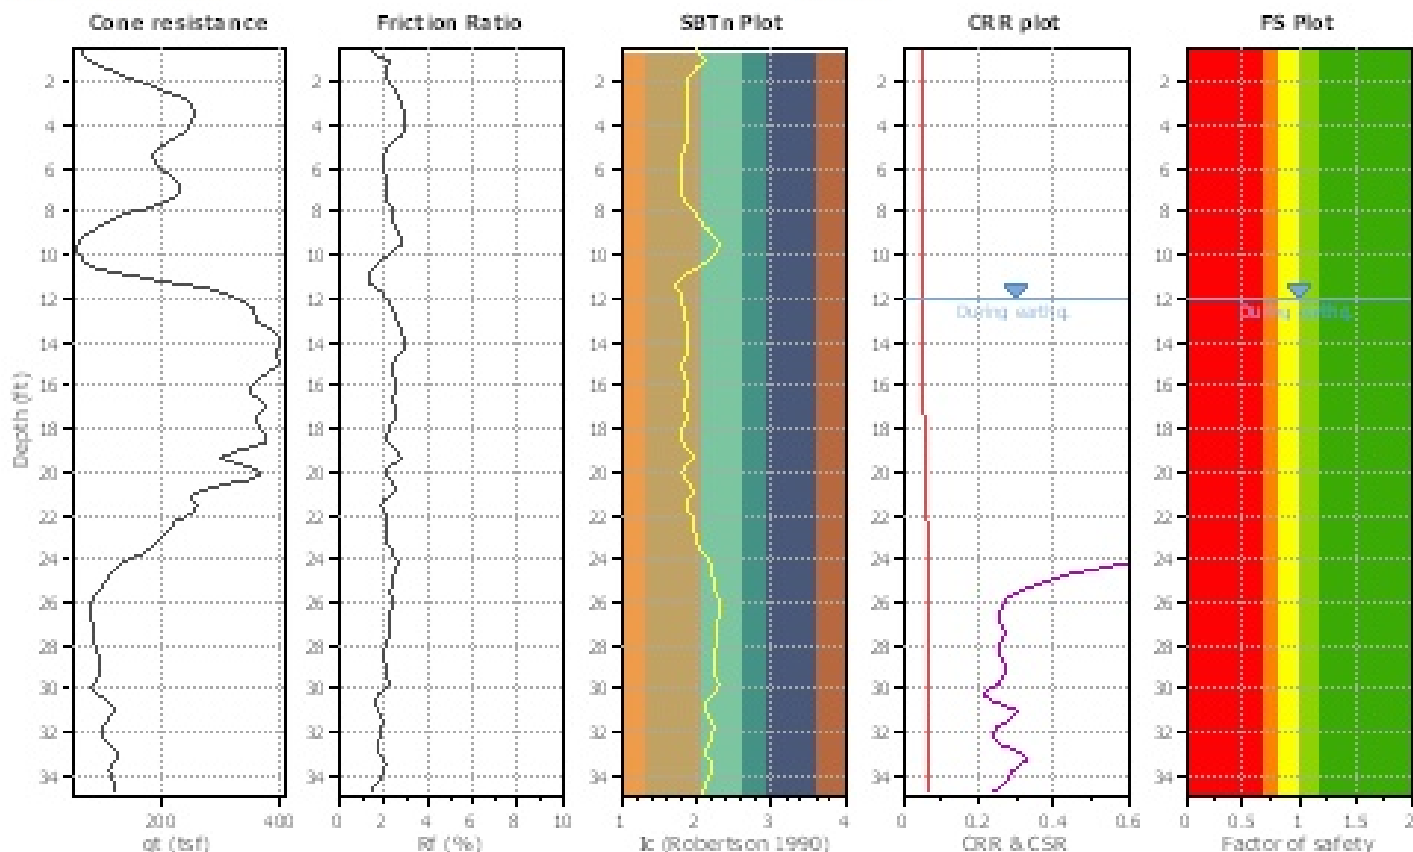
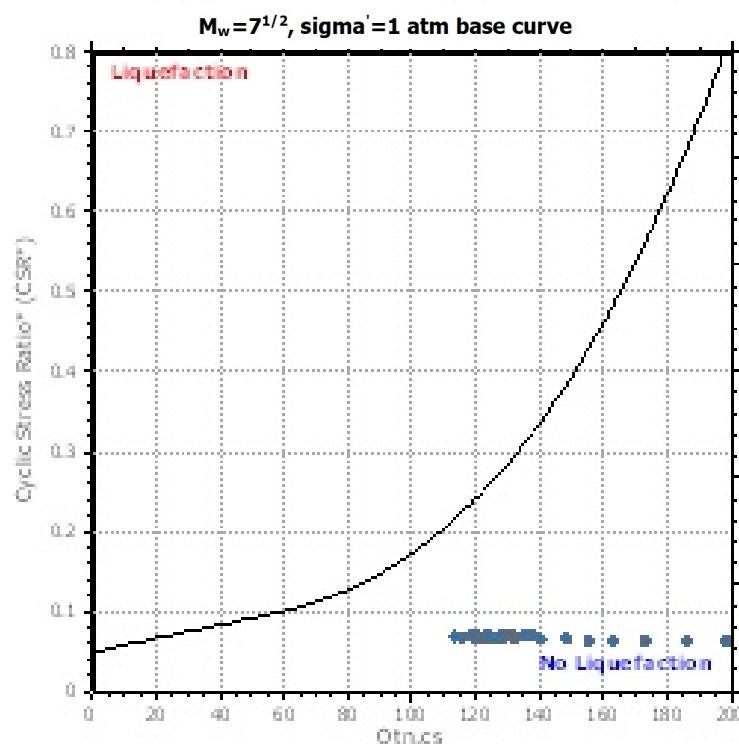
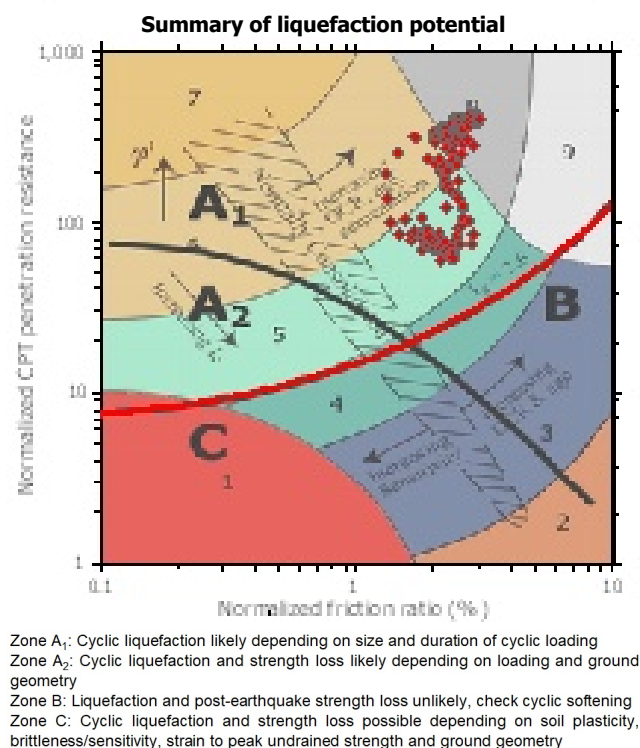
| Earthquake magnitude $M_w$ : | 7.00 | Ic cut-off value: | 2.60 | Trans. detect. applied: | No | Limit depth: | N/A |
| Peak ground acceleration: | 0.09 | Unit weight calculation: | Based on SBT | $K_\sigma$ applied: | Yes | MSF method: | Method based |

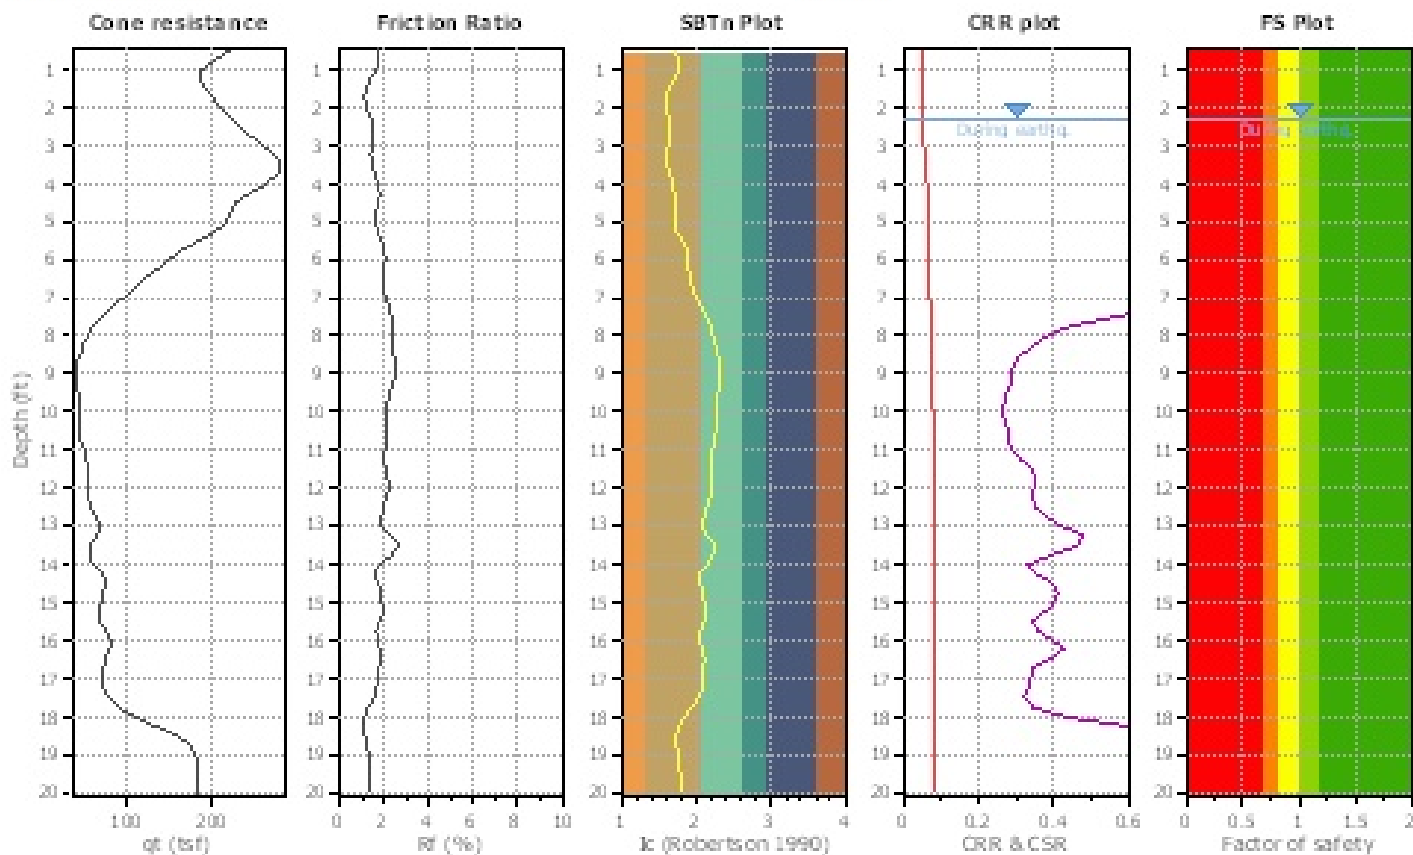
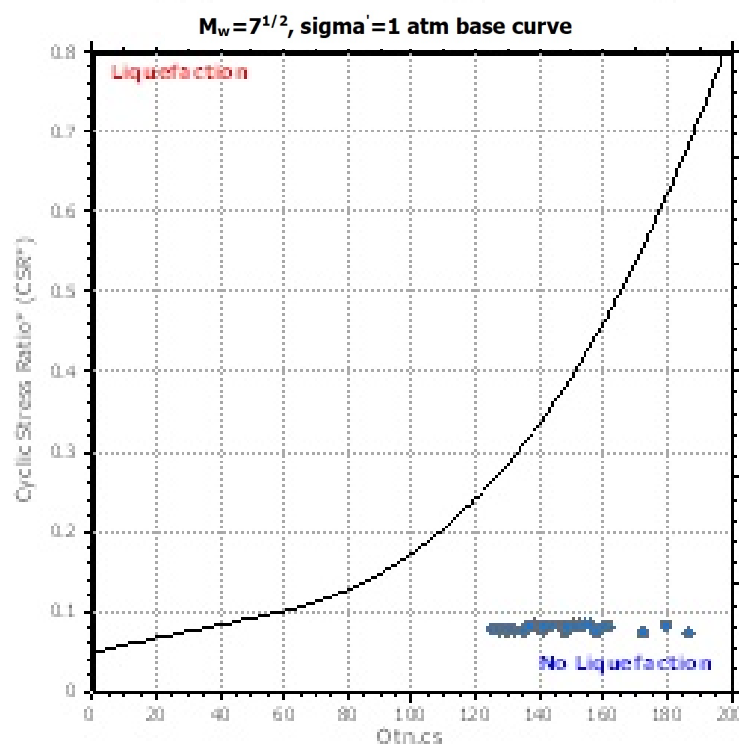
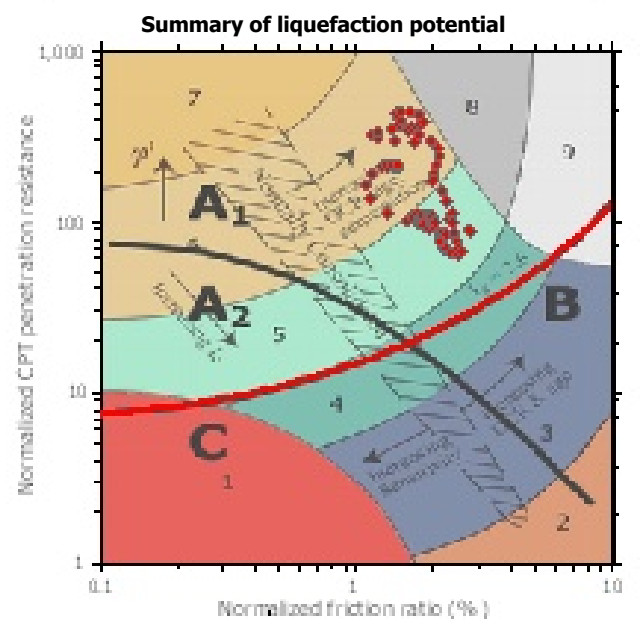
| Earthquake magnitude $M_w$ : | 7.00 | Ic cut-off value: | 2.60 | Trans. detect. applied: | No | MSF method: | Method based |
| Peak ground acceleration: | 0.09 | Unit weight calculation: | Based on SBT | $K_0$ applied: | Yes | | |

Zone A<sub>1</sub>: Cyclic liquefaction likely depending on size and duration of cyclic loading  
 Zone A<sub>2</sub>: Cyclic liquefaction and strength loss likely depending on loading and ground geometry  
 Zone B: Liquefaction and post-earthquake strength loss unlikely, check cyclic softening  
 Zone C: Cyclic liquefaction and strength loss possible depending on soil plasticity, brittleness/sensitivity, strain to peak undrained strength and ground geometry

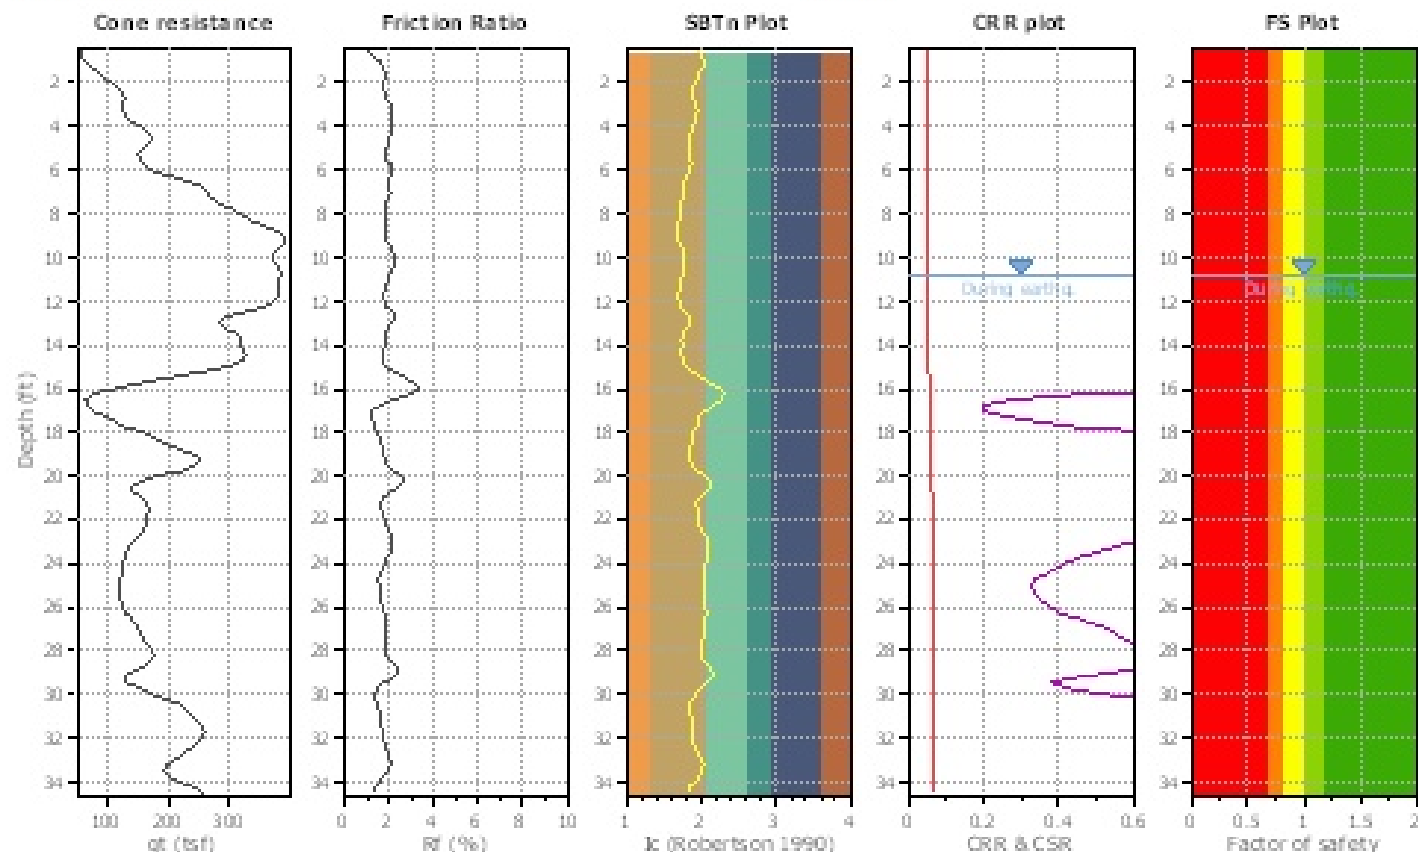
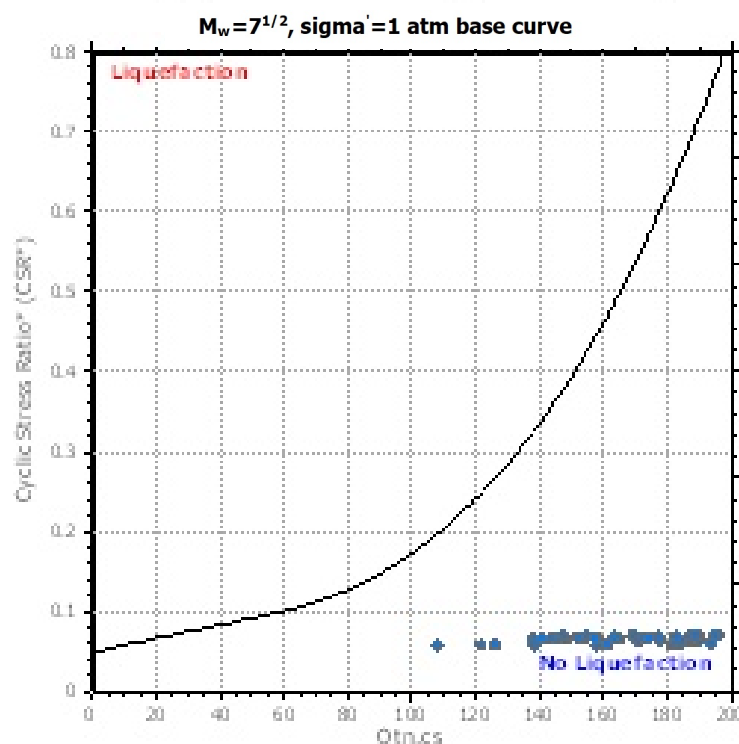
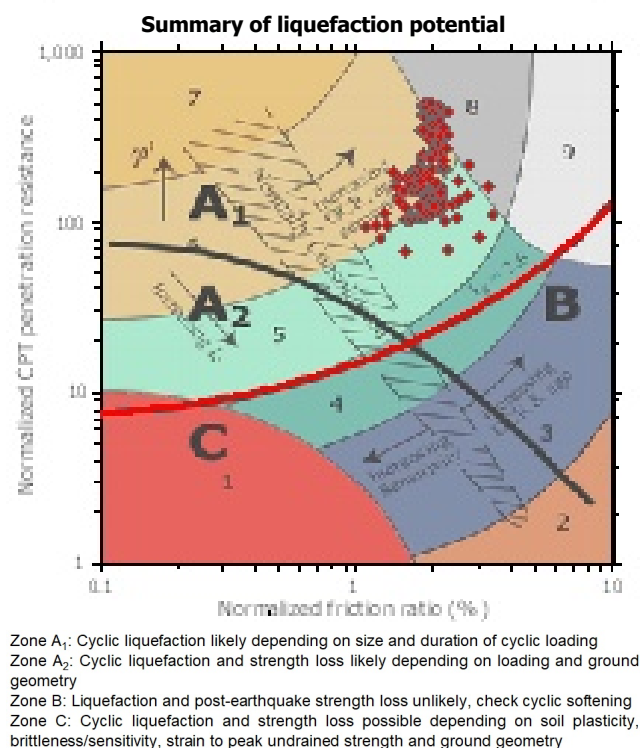
| Earthquake magnitude $M_w$ : | 7.00 | Ic cut-off value: | 2.60 | Trans. detect. applied: | No | Limit depth: | N/A |
| Peak ground acceleration: | 0.09 | Unit weight calculation: | Based on SBT | $K_0$ applied: | Yes | MSF method: | Method based |

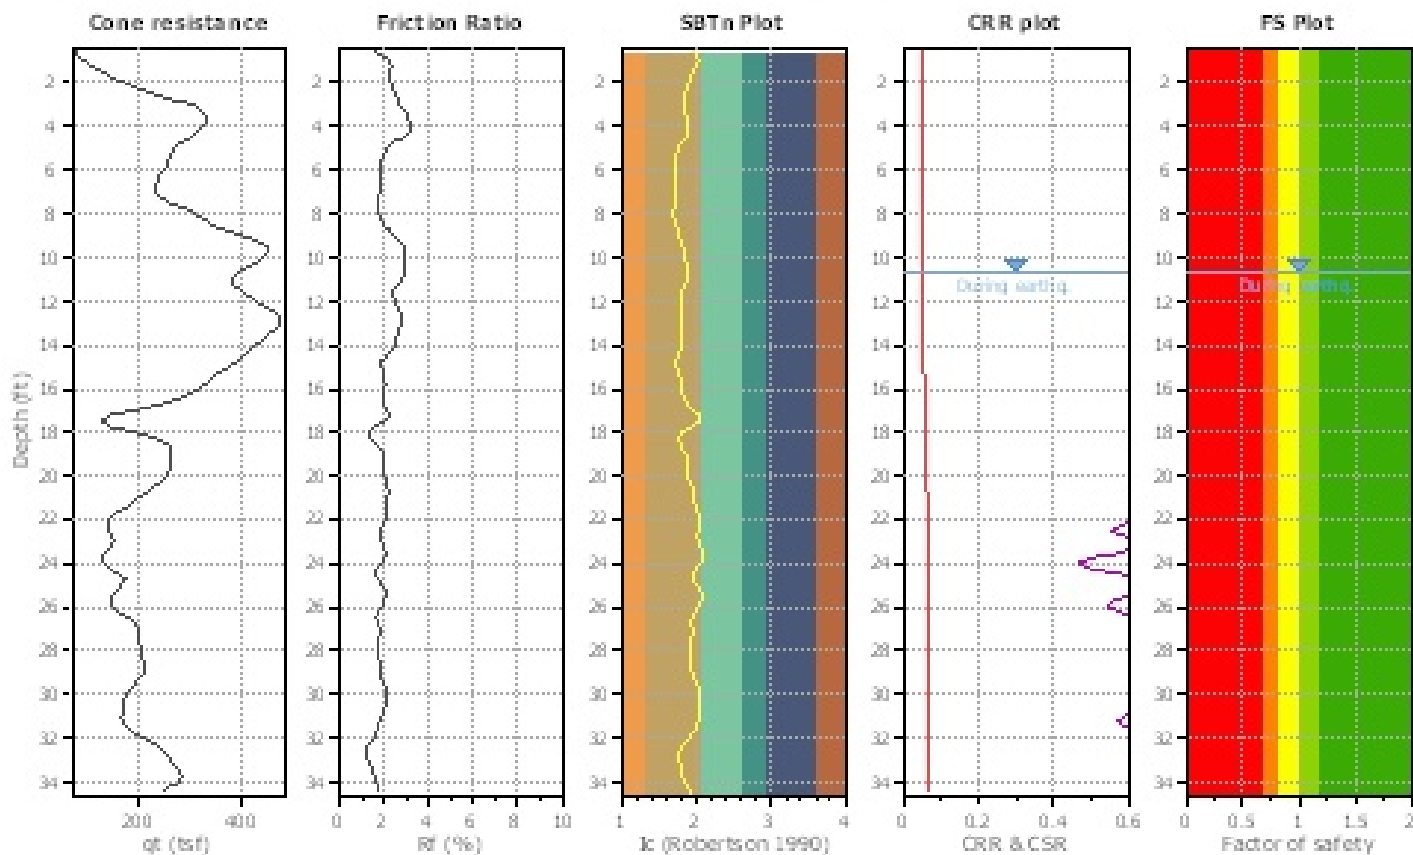
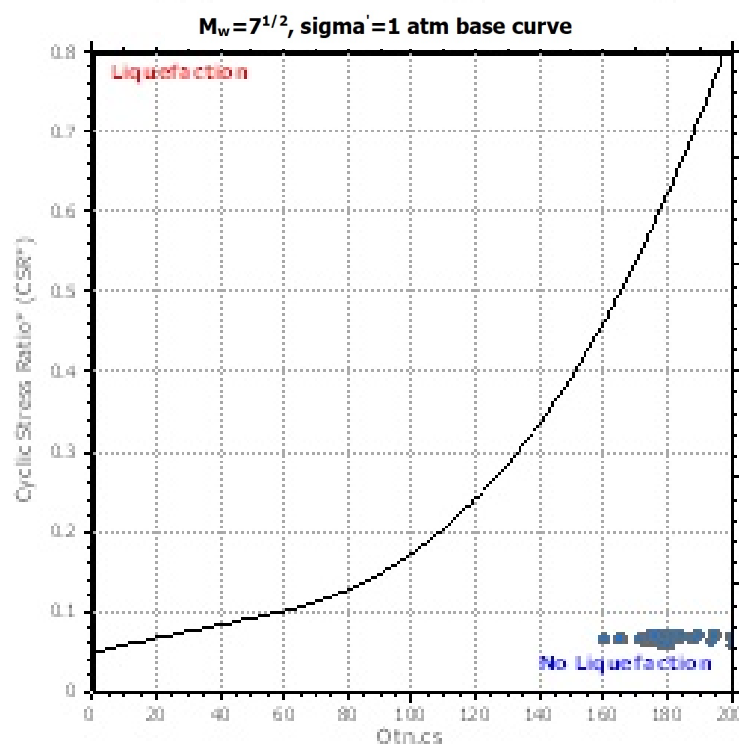
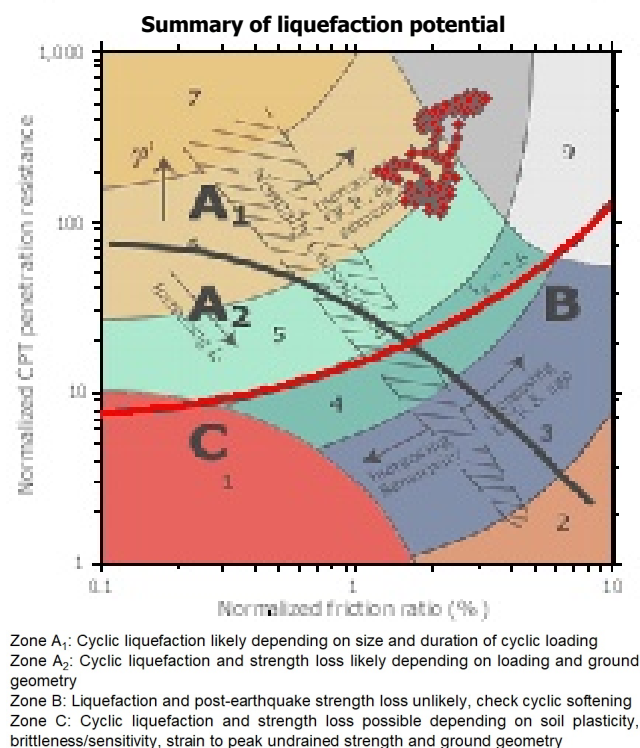
| Earthquake magnitude $M_w$ : | 7.00 | Ic cut-off value: | 2.60 | Trans. detect. applied: | No | Limit depth: | N/A |
| Peak ground acceleration: | 0.09 | Unit weight calculation: | Based on SBT | $K_\sigma$ applied: | Yes | MSF method: | Method based |
