**STRUCTURAL STABILITY AND SAFETY FACTOR  
ASSESSMENT per CCR Rule 257.73 (d) and (e)**

*NIPSCO, R.M. Schahfer Generating Station, Waste Disposal Area CCR Unit*

**Northern Indiana Public Service Company, LLC (NIPSCO)**

**WSP USA Inc.**

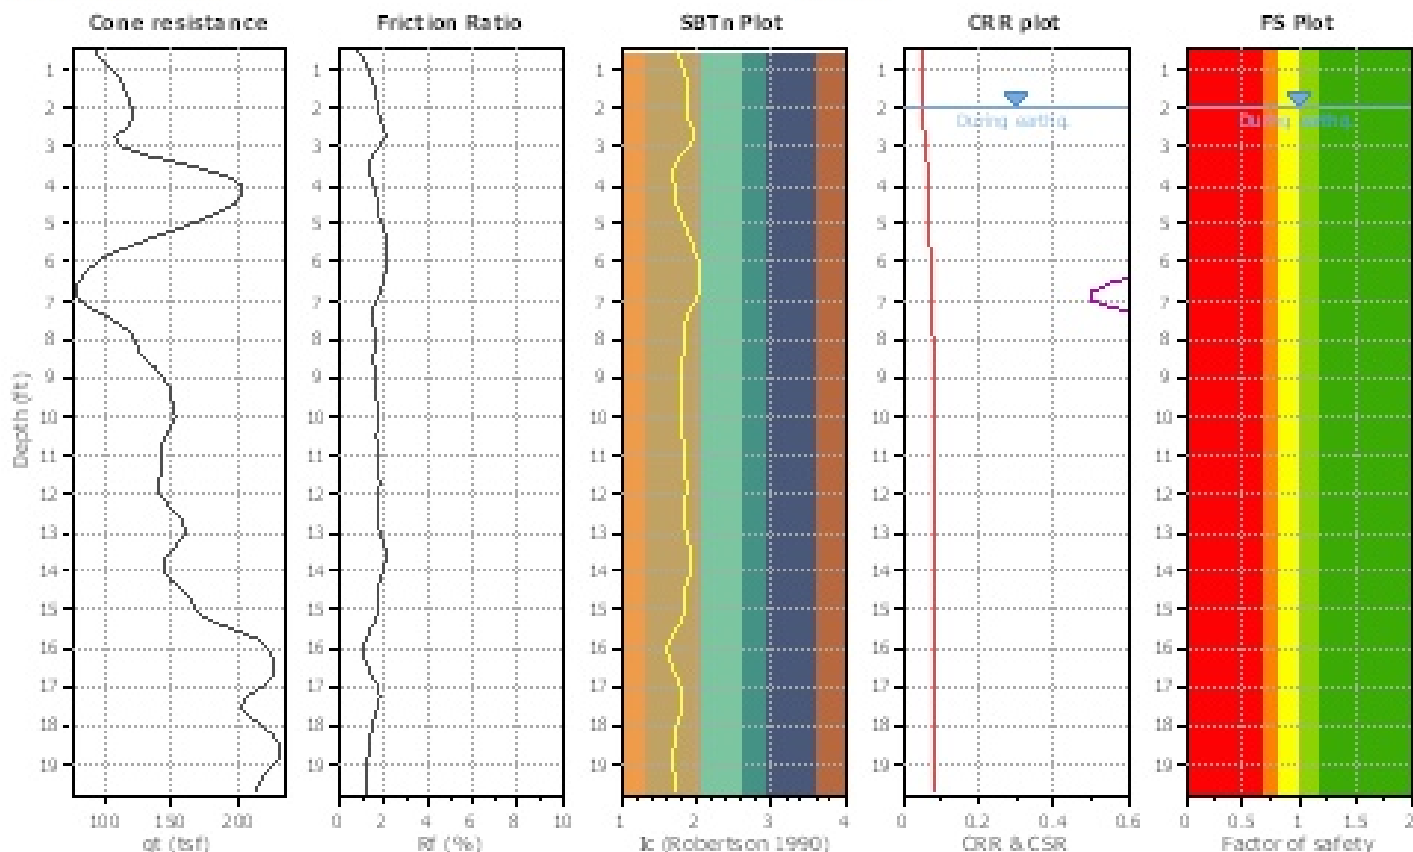
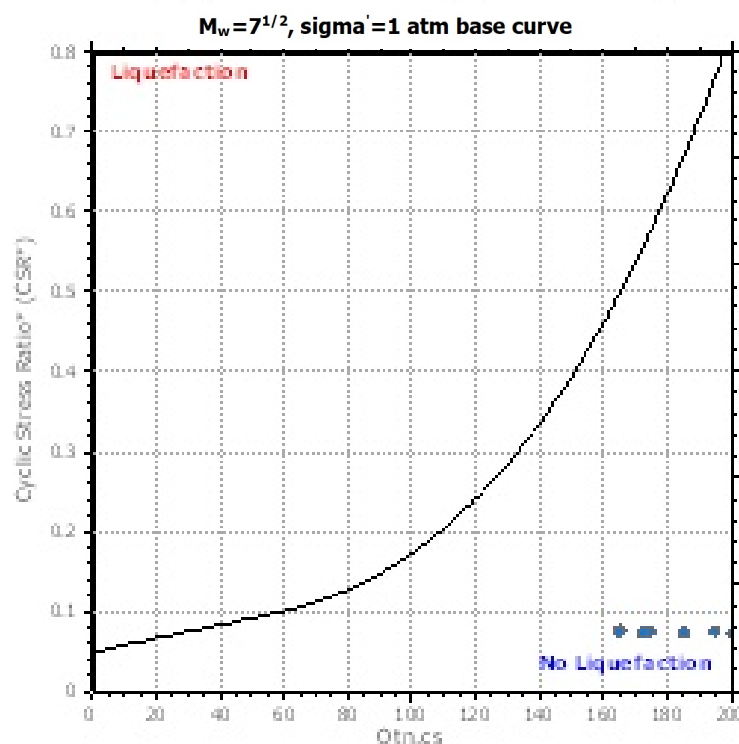
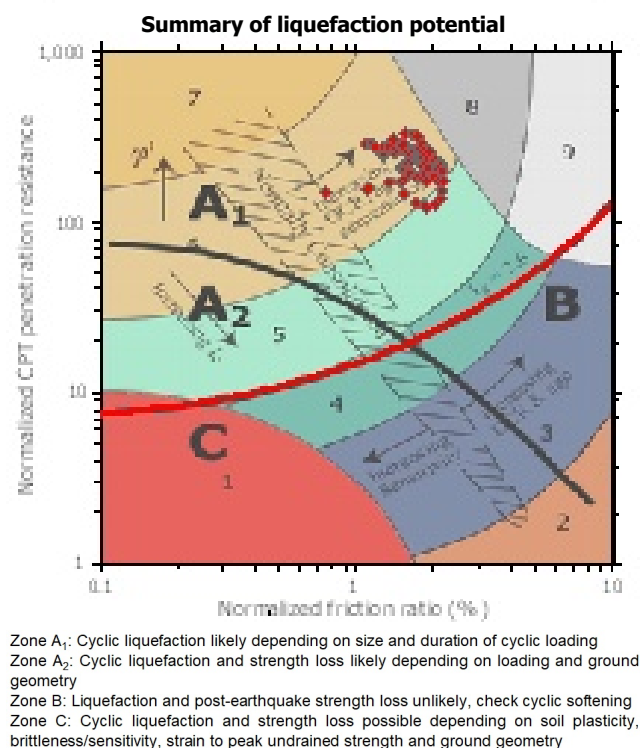
| Earthquake magnitude $M_w$ : | 7.00 | Ic cut-off value: | 2.60 | Trans. detect. applied: | No | Limit depth: | N/A |
| Peak ground acceleration: | 0.09 | Unit weight calculation: | Based on SBT | $K_0$ applied: | Yes | MSF method: | Method based |

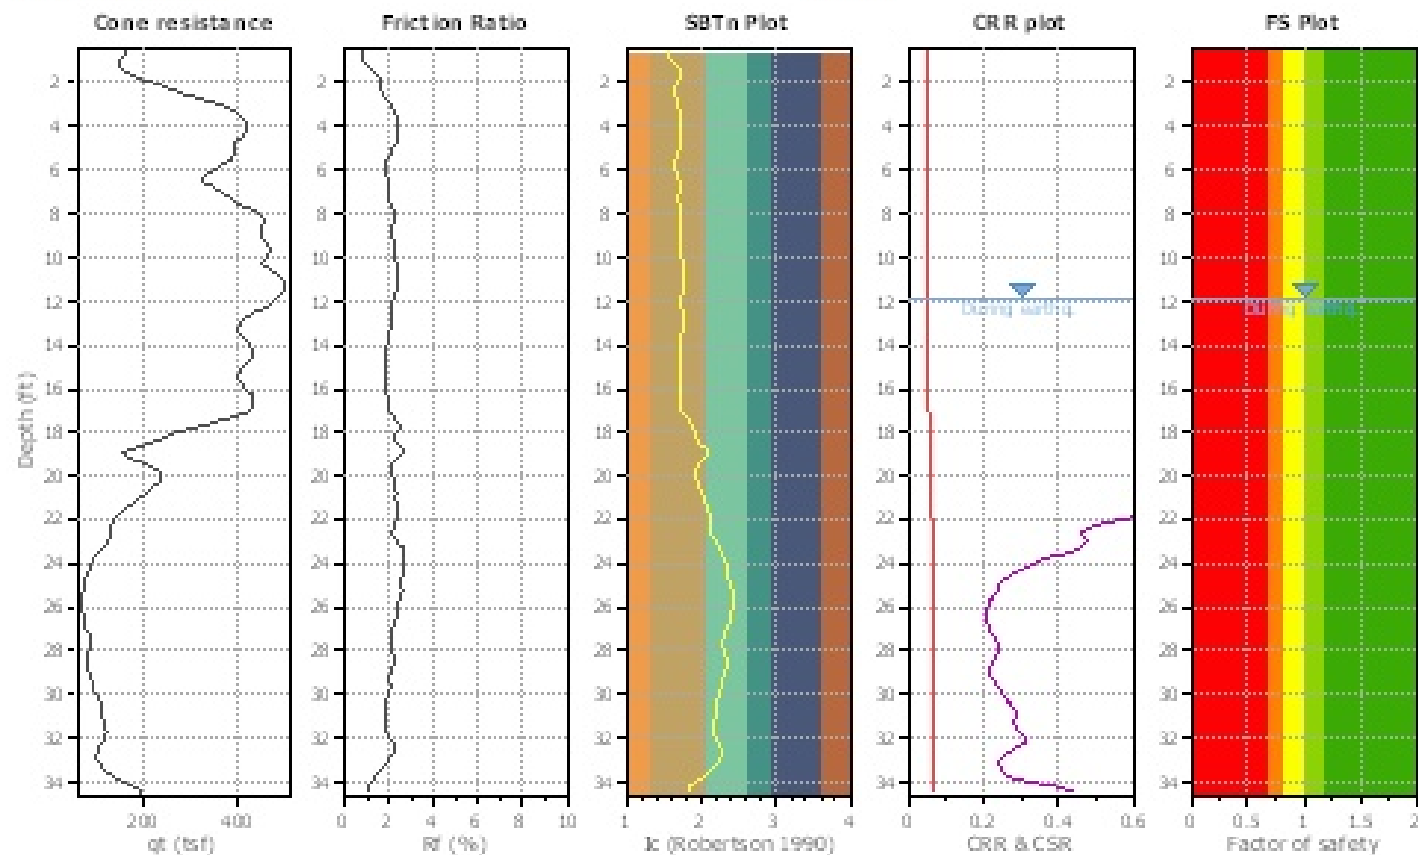
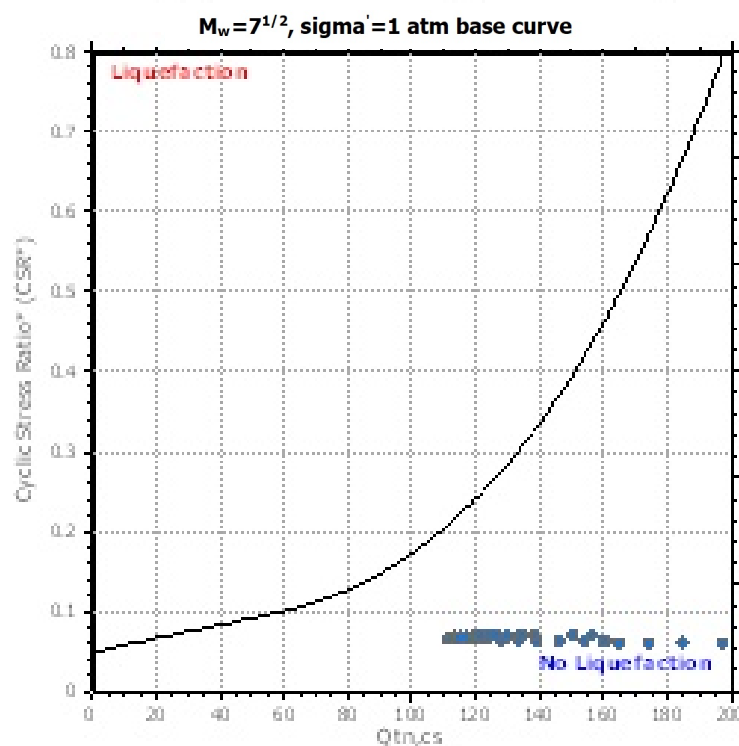
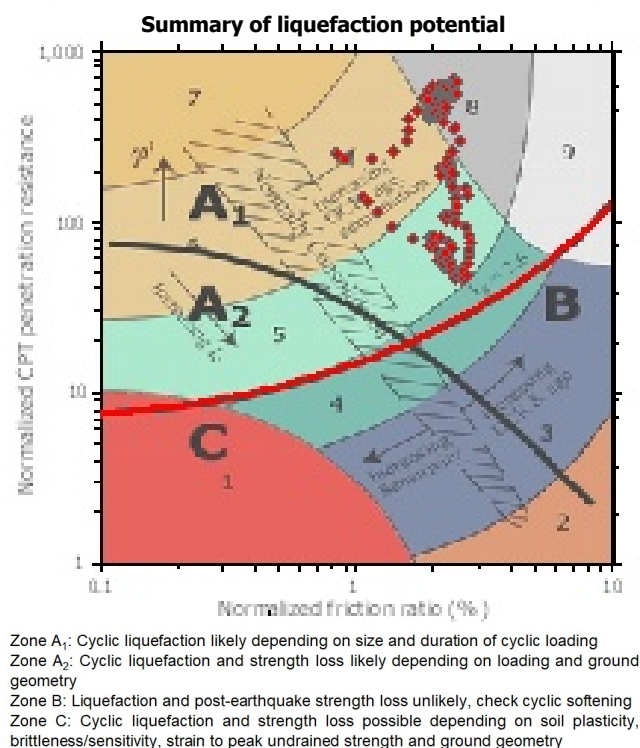
| Earthquake magnitude $M_w$ : | 7.00 | Ic cut-off value: | 2.60 | Trans. detect. applied: | No | Limit depth: | N/A |
| Peak ground acceleration: | 0.09 | Unit weight calculation: | Based on SBT | $K_0$ applied: | Yes | MSF method: | Method based |

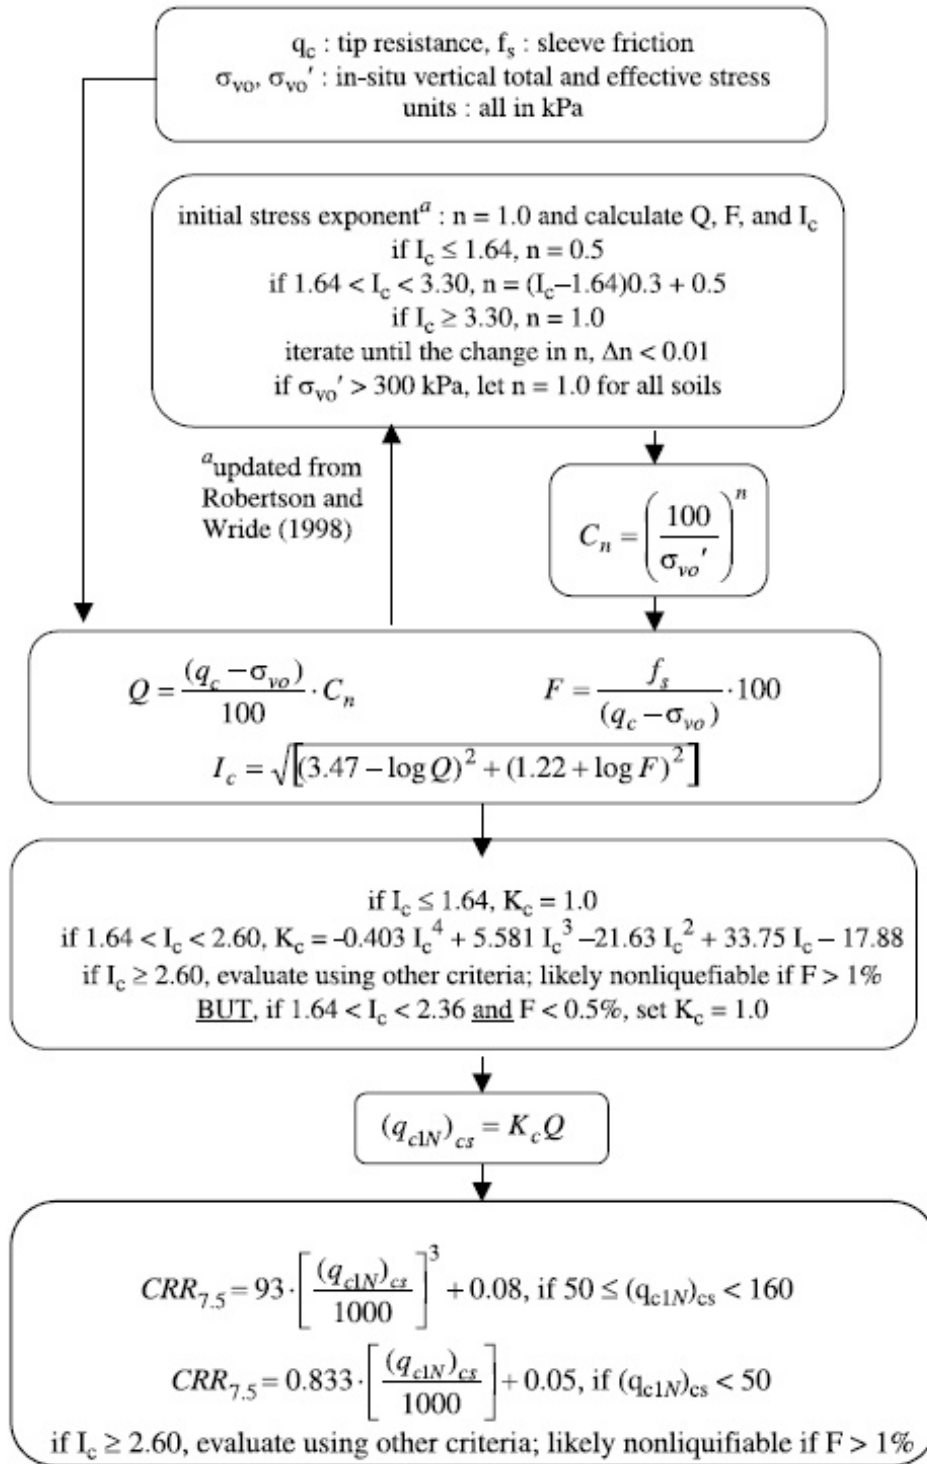
## Procedure for the evaluation of soil liquefaction resistance, NCEER (1998)

Calculation of soil resistance against liquefaction is performed according to the Robertson & Wride (1998) procedure. The procedure used in the software, slightly differs from the one originally published in NCEER-97-0022 (Proceedings of the NCEER Workshop on Evaluation of Liquefaction Resistance of Soils). The revised procedure is presented below in the form of a flowchart<sup>1</sup>:

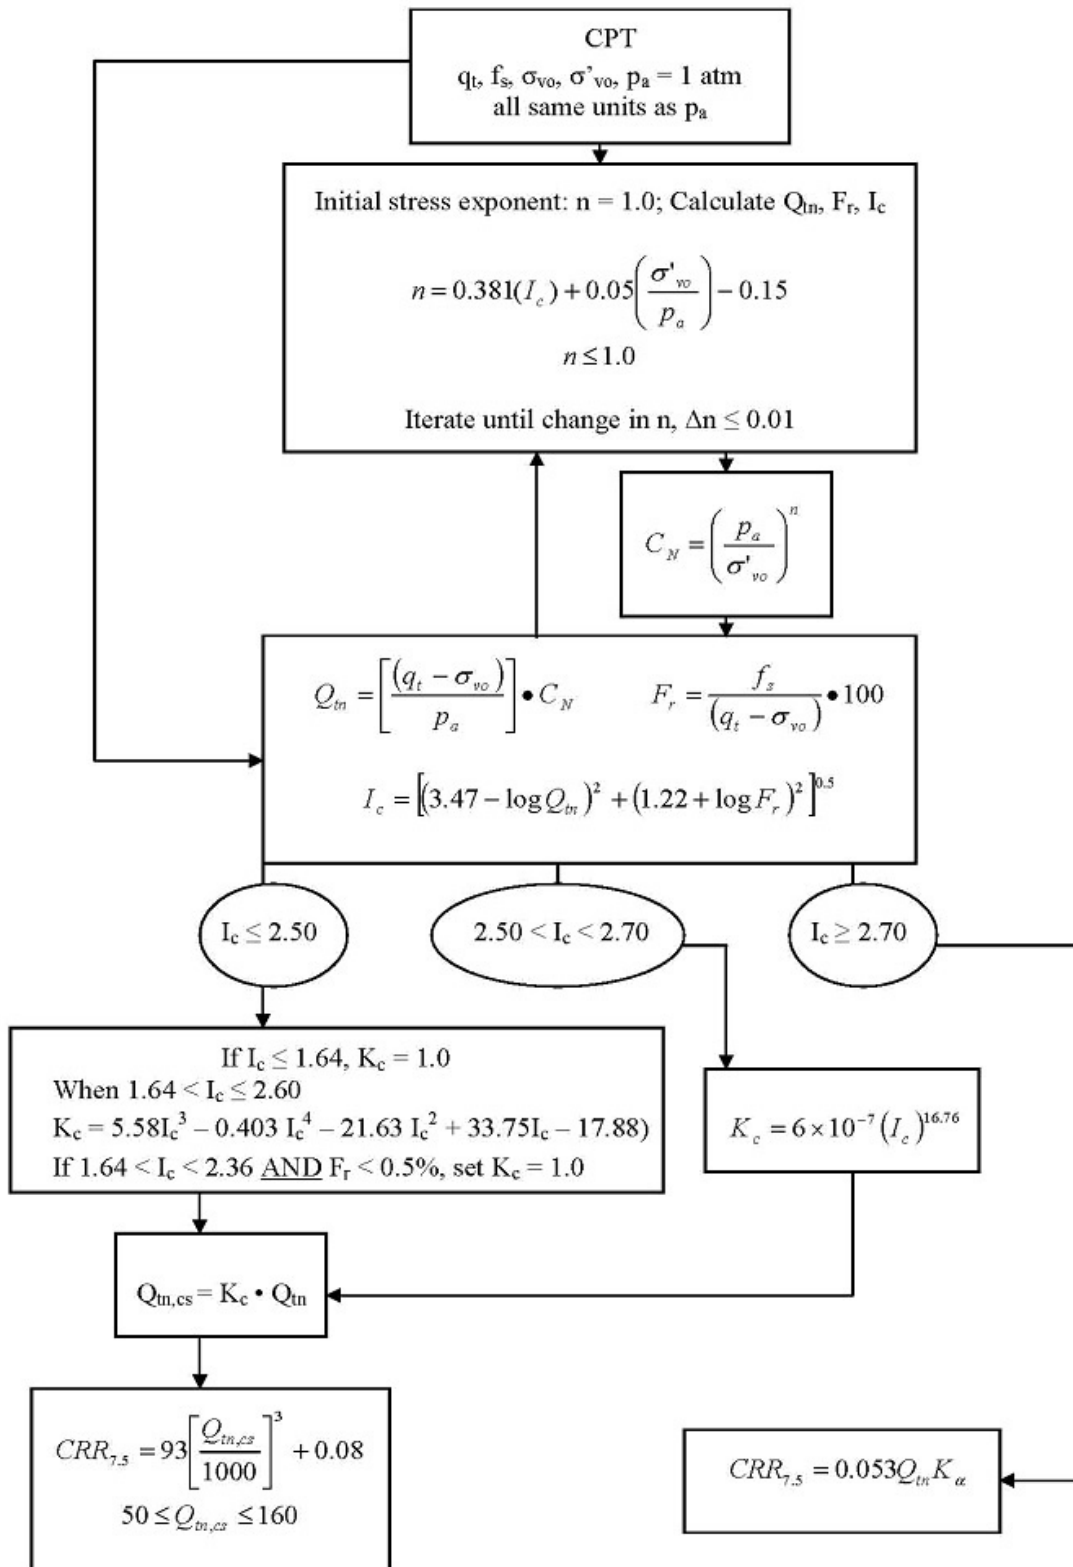
## Procedure for the evaluation of soil liquefaction resistance (all soils), Robertson (2010)

Calculation of soil resistance against liquefaction is performed according to the Robertson & Wride (1998) procedure. This procedure used in the software, slightly differs from the one originally published in NCEER-97-0022 (Proceedings of the NCEER Workshop on Evaluation of Liquefaction Resistance of Soils). The revised procedure is presented below in the form of a flowchart<sup>1</sup>:

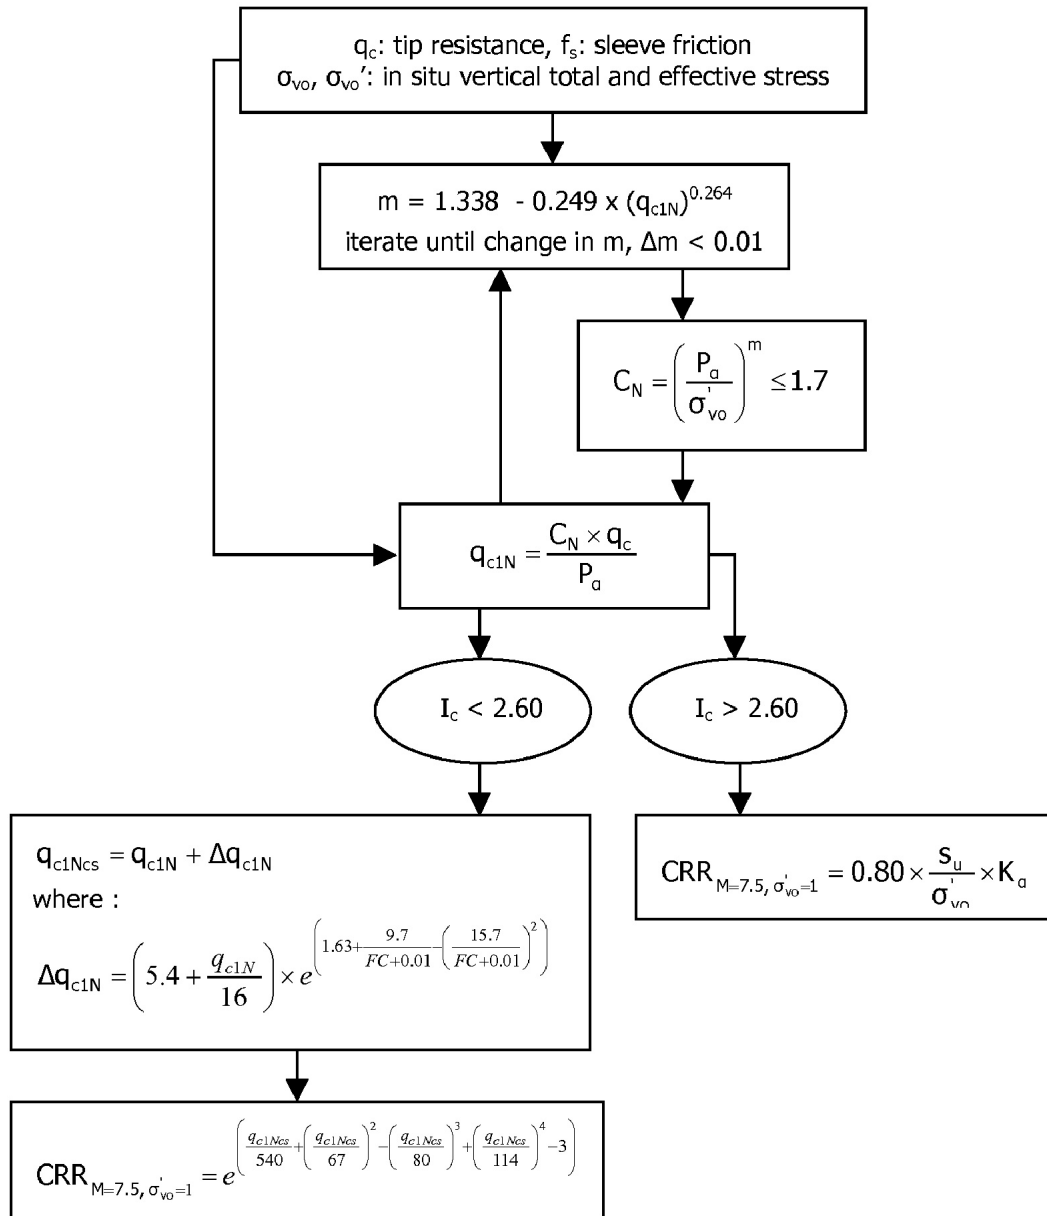
# **Procedure for the evaluation of soil liquefaction resistance, Idriss & Boulanger (2008)**

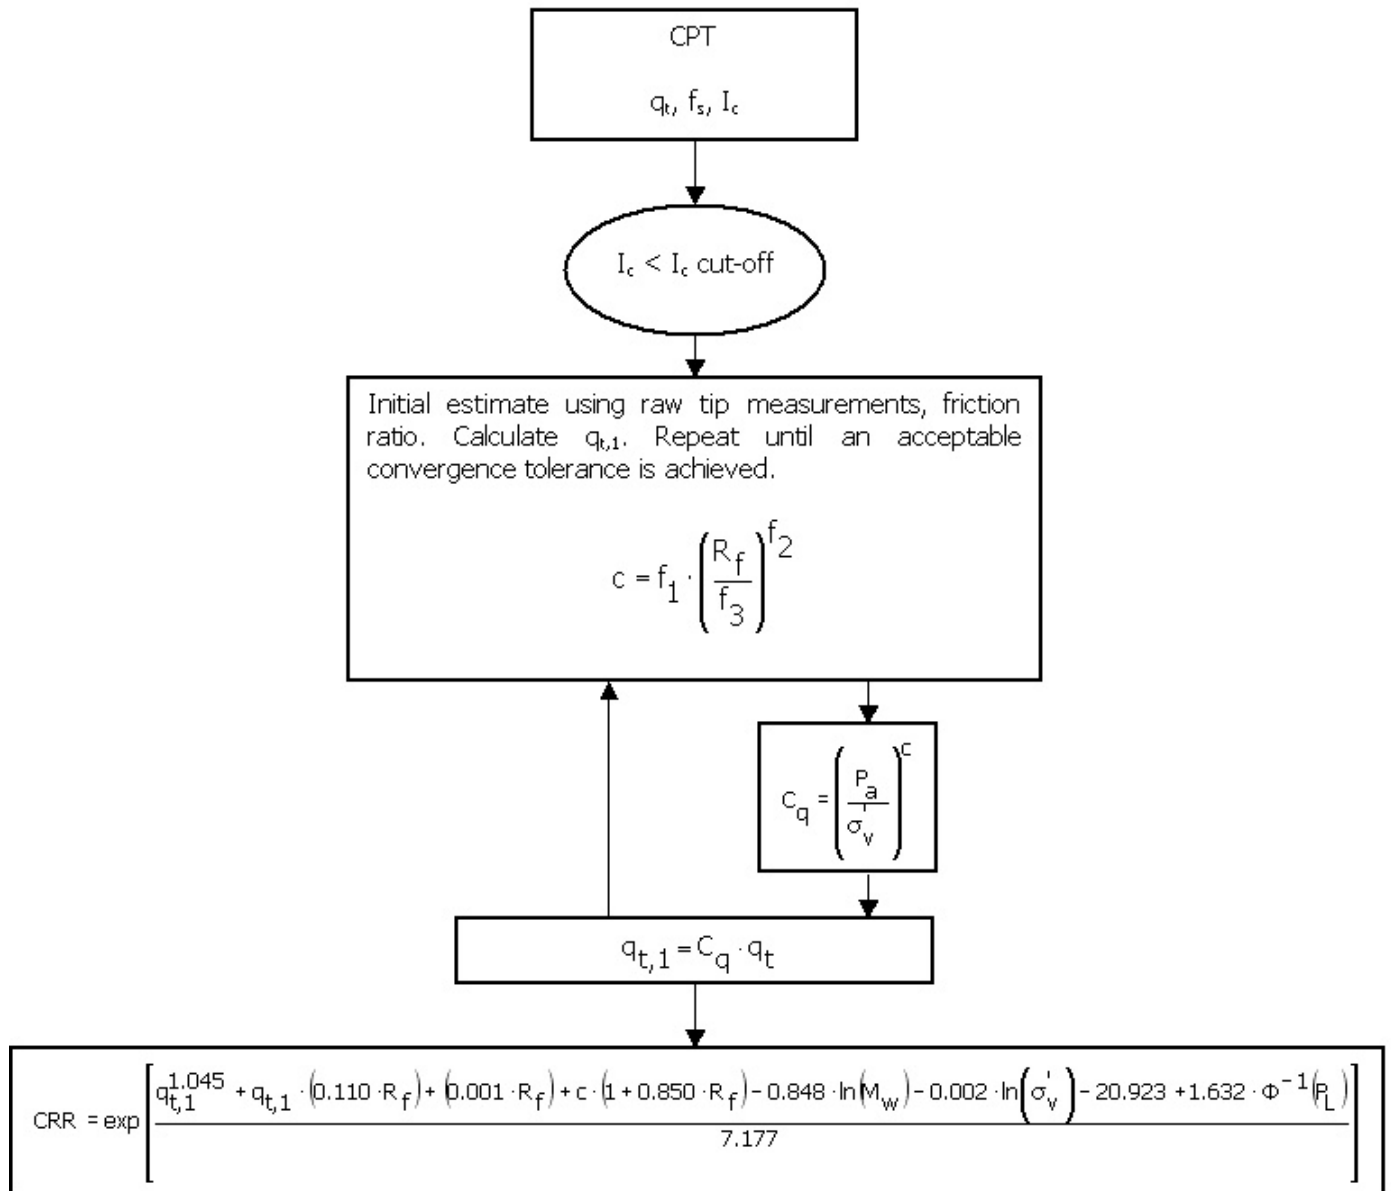
**Procedure for the evaluation of soil liquefaction resistance (sandy soils), Moss et al. (2006)**

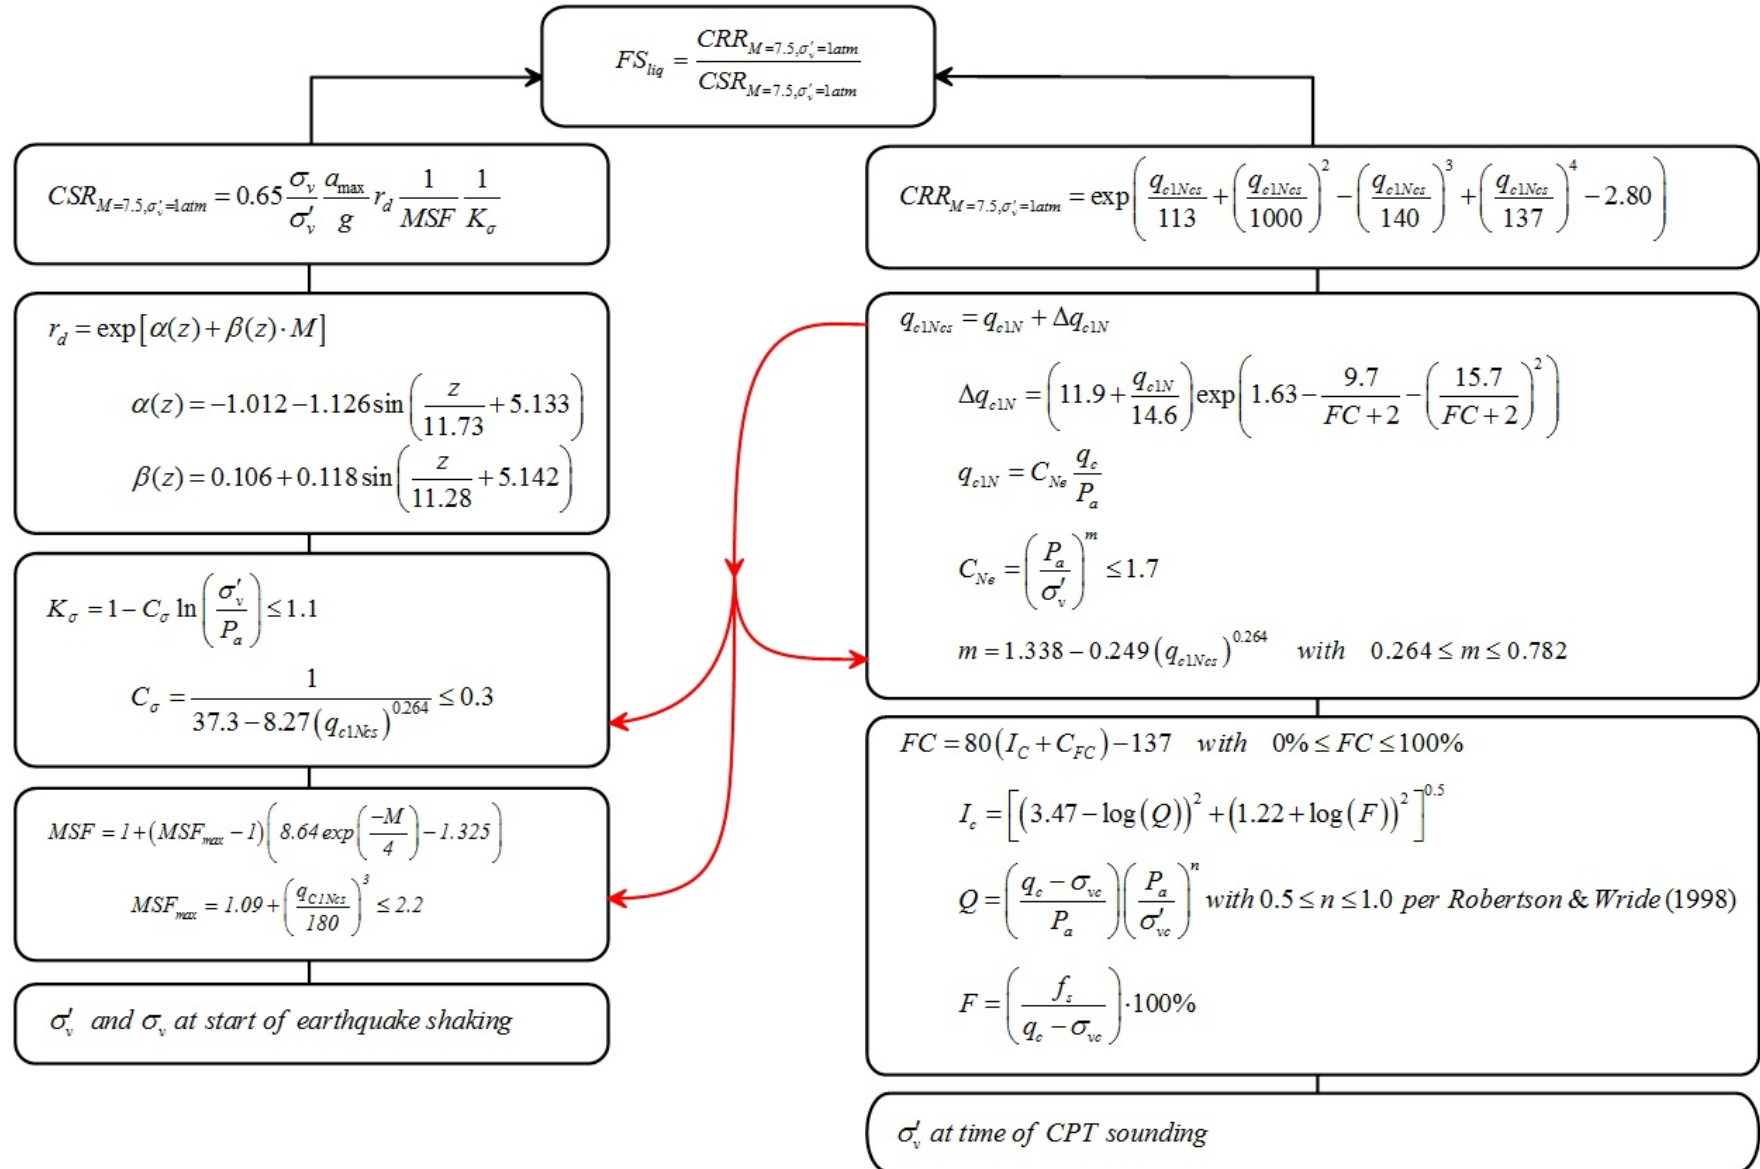
# Procedure for the evaluation of soil liquefaction resistance, Boulanger & Idriss(2014)

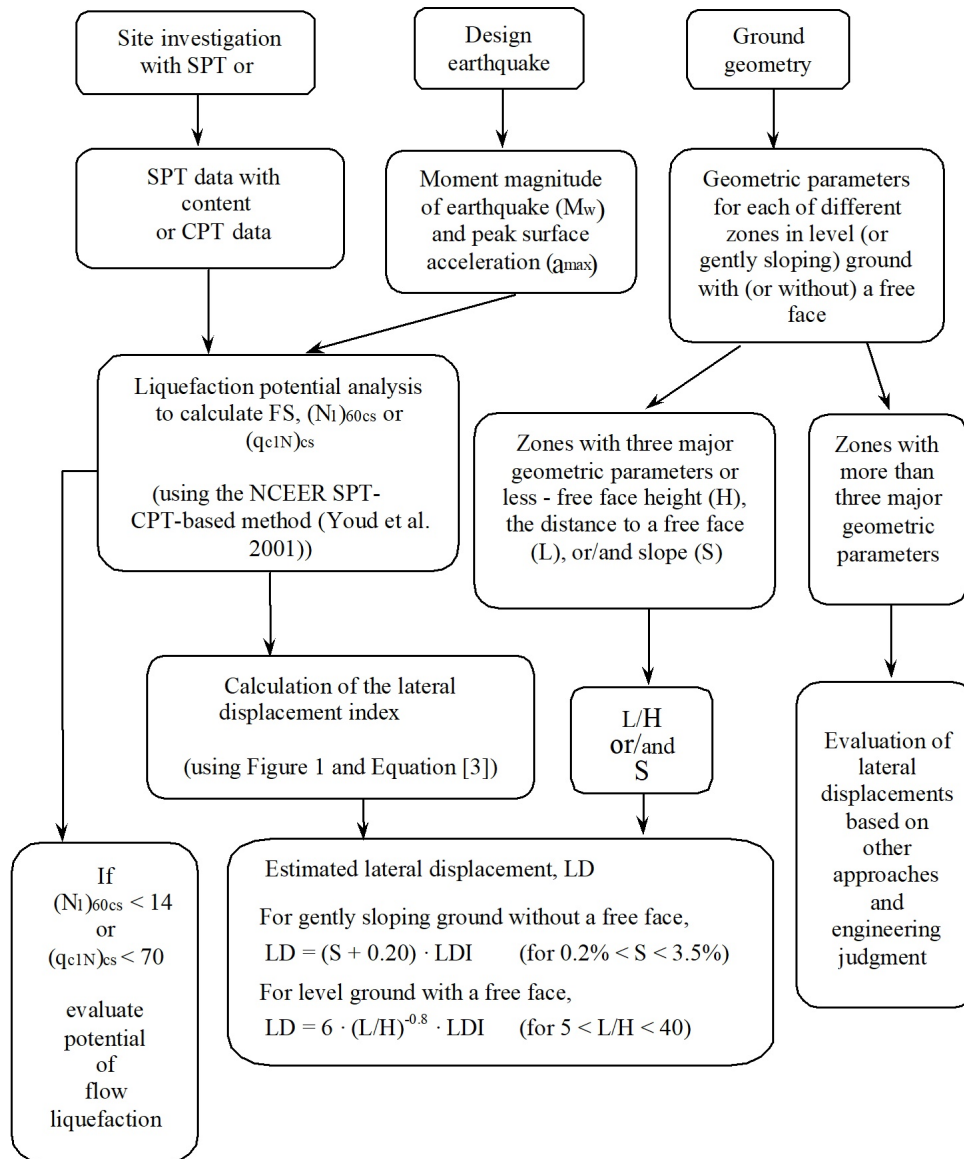
## Procedure for the evaluation of liquefaction-induced lateral spreading displacements

<sup>1</sup> Flow chart illustrating major steps in estimating liquefaction-induced lateral spreading displacements using the proposed approach

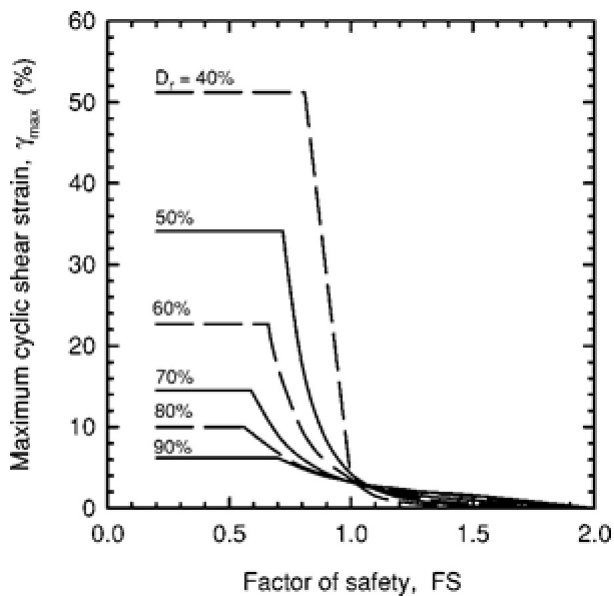
<sup>1</sup> Figure 1

$$LDI = \int_0^{Z_{\max}} \gamma_{\max} dz$$

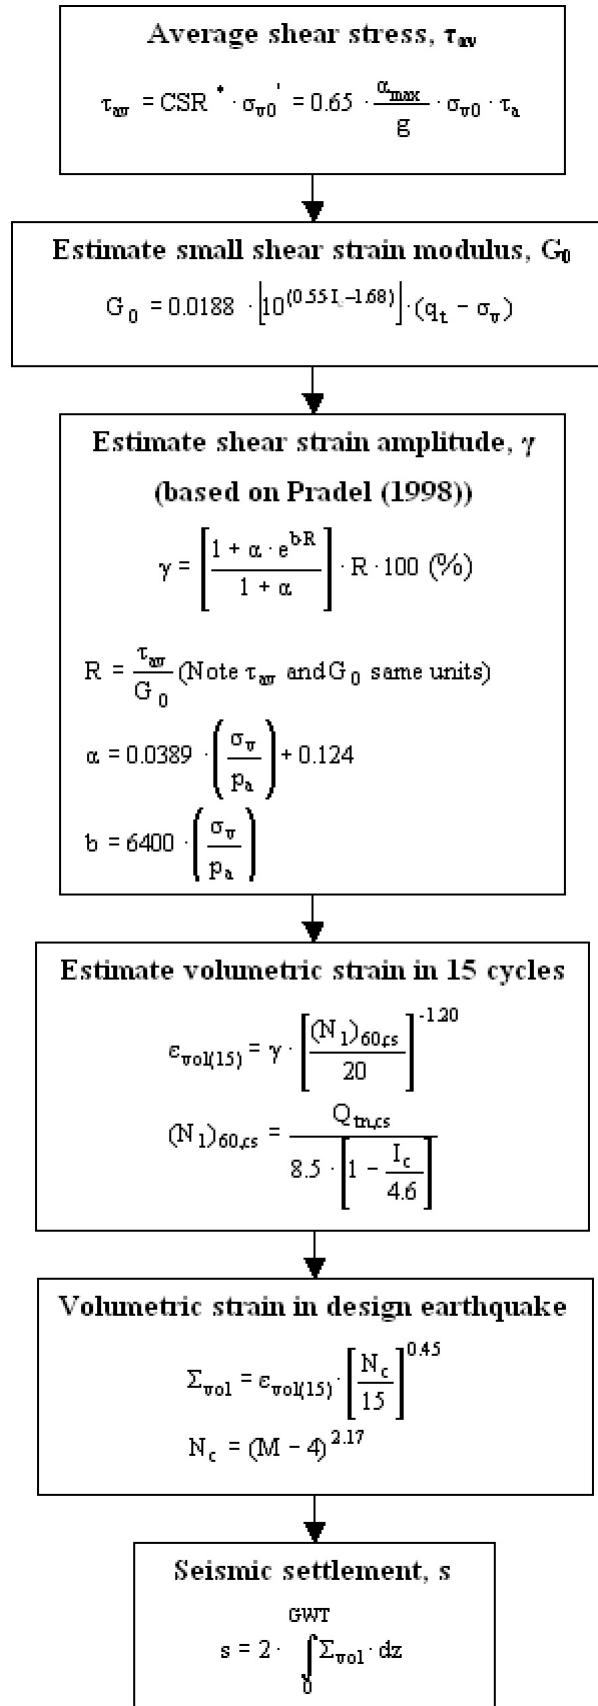
## Procedure for the estimation of seismic induced settlements in dry sands

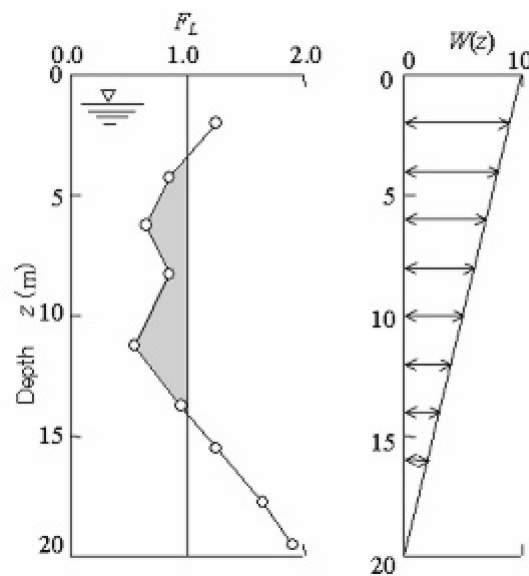
- LPI = 0 : Liquefaction risk is very low
- $0 < \text{LPI} \leq 5$  : Liquefaction risk is low
- $5 < \text{LPI} \leq 15$  : Liquefaction risk is high
- LPI > 15 : Liquefaction risk is very high

**Graphical presentation of the LPI calculation procedure**
